<b>EASA</b>	<b>AIRWORTHINESS DIRECTIVE</b>

<p><b>AD No.: 2014-0018R1</b>  <b>[Correction: 23 January 2014]</b></p> <p><b>Date: 20 January 2014</b></p> <p>Note: This Airworthiness Directive (AD) is issued by EASA, acting in accordance with Regulation (EC) No 216/2008 on behalf of the European Community, its Member States and of the European third countries that participate in the activities of EASA under Article 66 of that Regulation.</p>	
<p>This AD is issued in accordance with EU 748/2012, Part 21.A.3B. In accordance with EC 2042/2003 Annex I, Part M.A.301, the continuing airworthiness of an aircraft shall be ensured by accomplishing any applicable ADs. Consequently, no person may operate an aircraft to which an AD applies, except in accordance with the requirements of that AD, unless otherwise specified by the Agency [EC 2042/2003 Annex I, Part M.A.303] or agreed with the Authority of the State of Registry [EC 216/2008, Article 14(4) exemption].</p>

<p><b>Design Approval Holder's Name :</b> AIRBUS</p>		<p><b>Type/Model designation(s) :</b> A300, A300-600, A300-600ST and A310 aeroplanes</p>
<p>TCDS Numbers : France No. 145 and EASA.A.014</p>		
<p>Foreign AD : None</p>		
<p>Revis

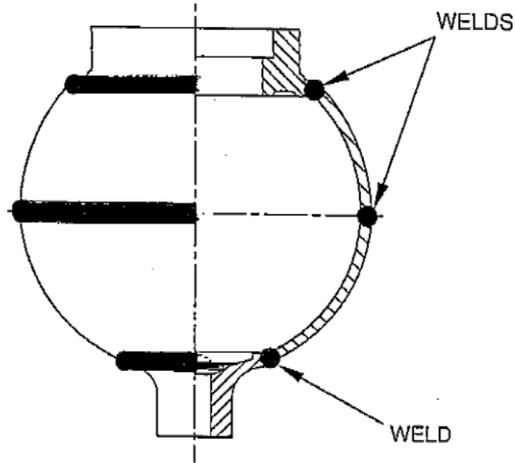
**OLD DESIGN**

**HYDRAULIC ACCUMULATOR** : designed with 4 parts and 3 welds

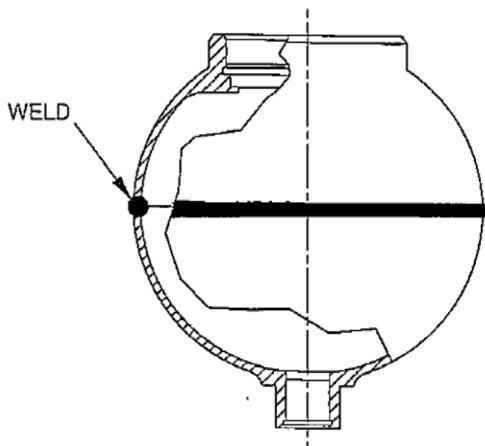
**NEW DESIGN**

**HYDRAULIC ACCUMULATOR** : designed with 2 parts and 1 weld
