| <b>EASA</b> | <b>AIRWORTHINESS DIRECTIVE</b> |
| | <p><b>AD No.: 2014-0133</b></p> <p><b>Date: 27 May 2014</b></p> <p>Note: This Airworthiness Directive (AD) is issued by EASA, acting in accordance with Regulation (EC) No 216/2008 on behalf of the European Community, its Member States and of the European third countries that participate in the activities of EASA under Article 66 of that Regulation.</p> |
| <p><b>Design Approval Holder's Name:</b><br/>VULCANAIR S.p.A.</p> | <p><b>Type/Model designation(s):</b><br/>P.68 aeroplanes</p> |
| <b>ATA 77</b> | <b>Engine Indicating System – Multifunction Engine Gauge – Inspection / Replacement</b> |

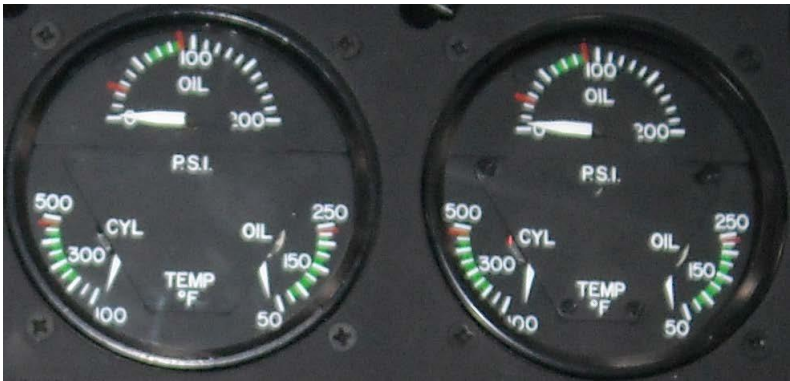
Figure 1. Correct configuration with Weston P/N 22-804-01-19A or A.I.D. P/N 18-1000-11

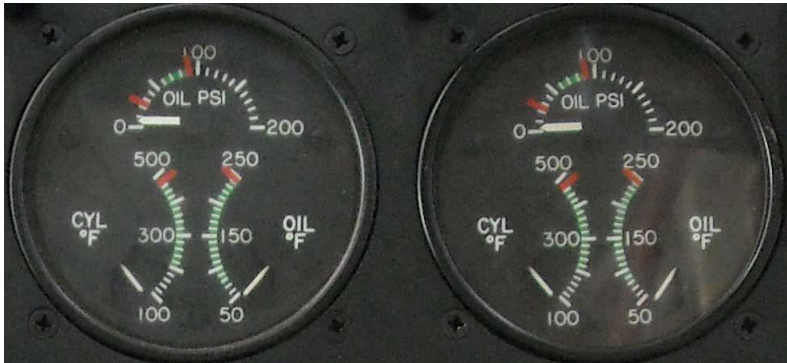
Figure 2. Correct configuration with Sigma Tek (Edo Aire) P/N 1U378-003-20, or P/N 1U378-003-20A
