Apex Aircraft Bureau de Navigabilité 1, route de Troyes 21121 DAROIS - France Tél +33 380 35 65 10 Fax +33 380 35 65 15 www.apex-aircraft.com	S E R V I C E B U L L E T I N No. 030906
CAP10B - Wings - Inspection and service life	ATA : 050
Supersedes : SB 16 all revs

Models	Serial numbers affected
CAP10B with wood-only wing spar.	01-04, 1 to 282 <u>except</u> with modification 000302 ("CAP10C" wing)

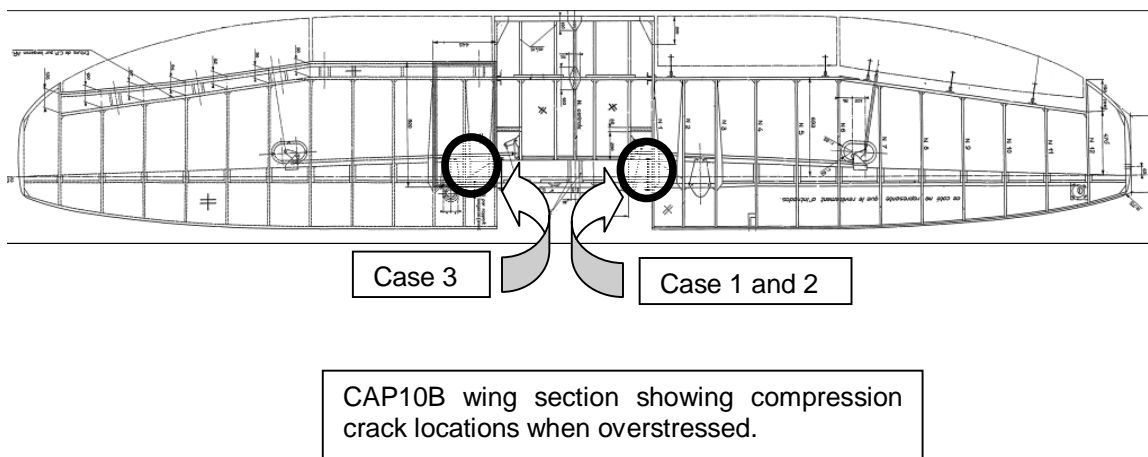
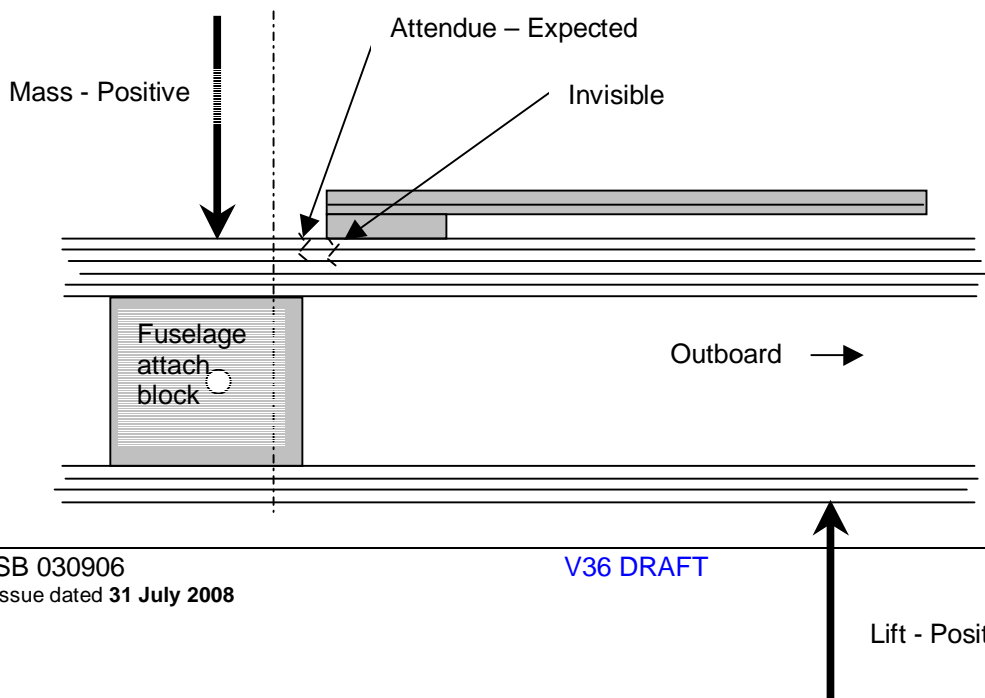
CASE 1: A fatal wing failure in Texas in June of 2003, was not prevented. In the Texas case, the wing failed at a pre-existing crack which was not in the Rib 1 inspection area. The crack was offset outboard slightly, possibly due to improper woodworking technique in the execution of SB 16, in 1992. When the skin and wingwalk support were routed to expose the likely area of compression cracks, the router cut some fibers of the spar cap. This 0.6 mm cutting of the spar may be commonplace, and only becomes an issue at overstress, when cracks begin. Such cracks are not visible because they start in the very corner of the inspection area.

The left spar failed at the edge of the inspection area, where a compression crack had failed the top one of five laminates completely, and progressed into the second laminate. This failure appears to pre-date the accident by some time.

On the right spar root, which did not fail, there was a visible compression crack. Also, there existed a larger compression crack in the right wing root hidden in the corner of the inspection area. The NTSB has recorded digital images.

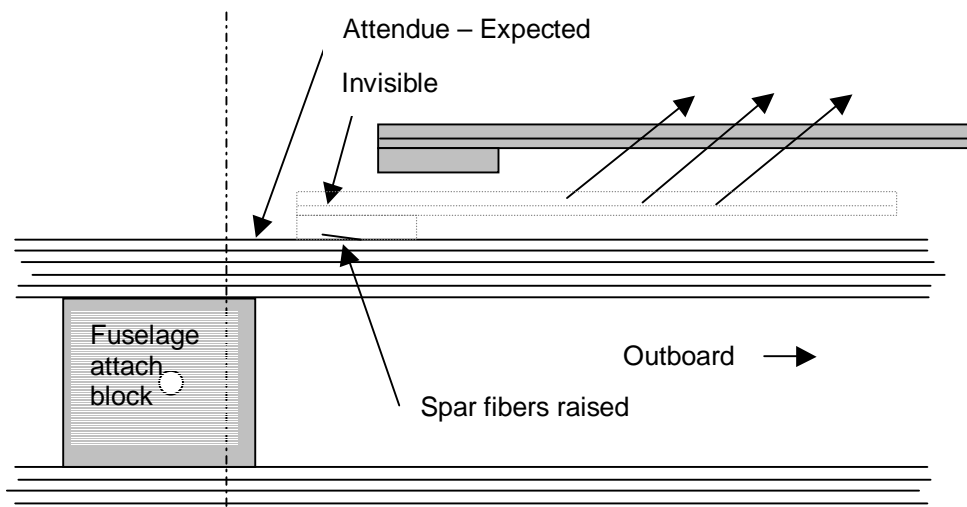
CASE 2: New Hampshire, USA, Inspections – No incident or accident

Shallow splits in the upper spar cap have been recently found between Rib 1 and 2 in two other CAP10B. The first became evident from detachment of the inboard forward end of the wing walk reinforcement. More significantly, the second of these had no evidence until the spar was uncovered. While these aircraft have previously been inspected for overloads, records were not kept of the load factor or masses involved. In both cases, the splits were less than 5 mm deep.

It is not certain that these splits are the result of tension from heavy negative flight loads, but this is the most likely reason. Preliminary experiments at Apex indicate that shear loads can create such splits. These could result from the wing-walk reinforcement, reacted by the wing-walk itself, shearing from the spar during heavy flexing loads.

This case causes the uncovering of the spar for all wooden spars

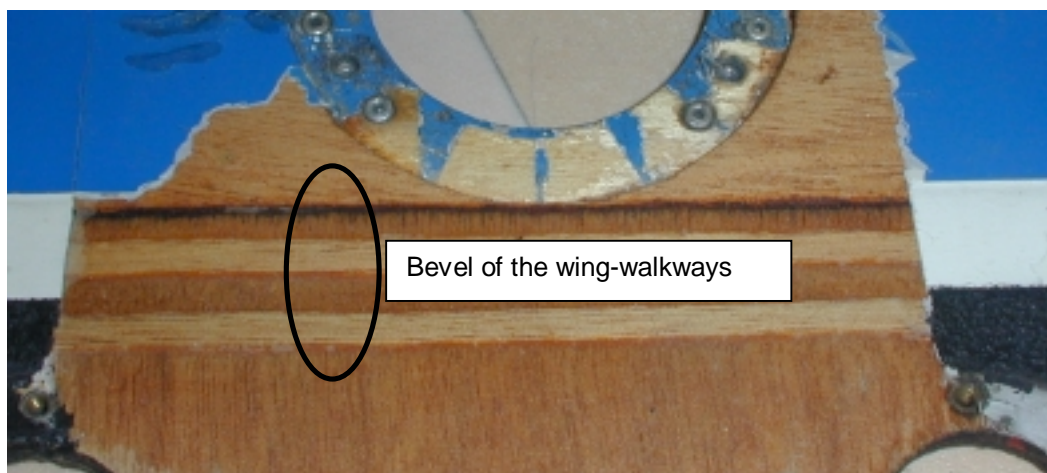
Photo 1 : part of wing-walkway bevel kept to trace the slope.

- a) Measure and record the slope of the wing-walkway bevel (for instance by keeping part of it) to allow preparing the replacement part (refer to following photo).

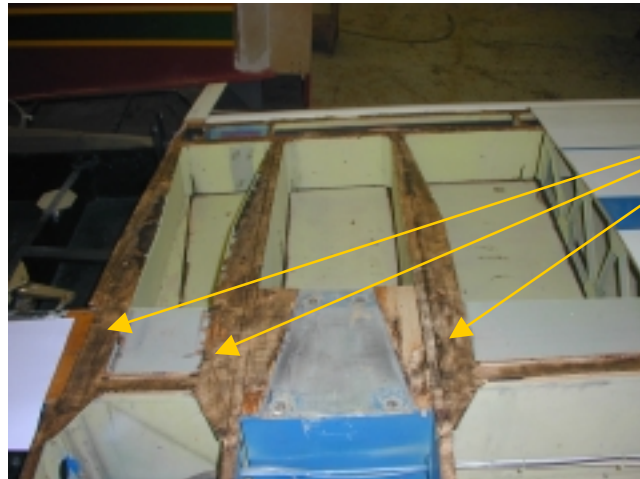
Wing-walkway
reinforcement

Photo 2 : with skin removed.

Remove the wing upper surface skin from leading edge to trailing edge, from inboard of rib 4 to the fuselage on left and right, per illustration b. to do so, cut first between the ribs, then carefully remove the remaining skin from the ribs using chisel, scraper and sander. **Make sure not to damage the ribs.**

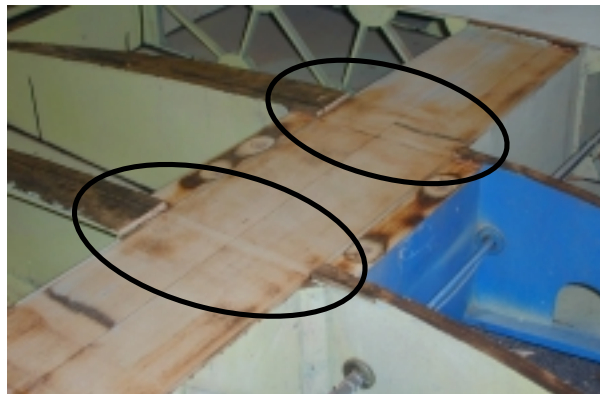
Photo 3: example of airplane with reinforcements in good condition. Therefore the only parts removed were covering the main spar.

- b) Tap test, and gently pull-test, all of the wingwalk reinforcements which are glued to spar. Log any locations where bond failure are suspected.
- c) Remove the reinforcements if any damage shown. If no damage shown, only cut and remove the parts of the reinforcements and the top of the ribs covering the main spar (refer to following example).
