| <b>EASA</b> | <b>AIRWORTHINESS DIRECTIVE</b> |
| | <p><b>AD No.: 2010-0044</b></p> <p><b>Date: 17 March 2010</b></p> <p>Note: This Airworthiness Directive (AD) is issued by EASA, acting in accordance with Regulation (EC) No 216/2008 on behalf of the European Community, its Member States and of the European third countries that participate in the activities of EASA under Article 66 of that Regulation.</p> |
| <b>Type Approval Holder's Name :</b><br>AIRBUS | <b>Type/Model designation(s) :</b><br>A340-200/-300 aeroplanes |
| <b>ATA 78</b> | <b>Exhaust – Thrust Reverser Actuation System Doors – Replacement</b> |

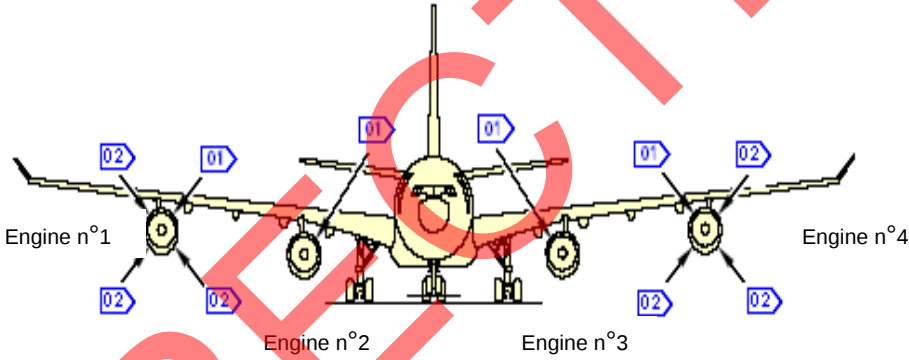
| Required action(s) and Compliance Time(s): | <p>Required as indicated, unless accomplished previously:</p> <ol style="list-style-type: none"> <li>(1) No later than 28 February 2011, do the actions specified in paragraph (3) of this AD on the upper inboard thrust reverser pivoting door of each engine, as identified by the label <b>01</b> in Picture 1 below.</li> <li>(2) No later than 31 December 2012, do the actions specified in paragraph (3) of this AD on the upper outboard thrust reverser pivoting doors of engines n°1 and n°4, and lower thrust reverser pivoting doors (inboard and outboard) of engines n°1 and n°4 as identified by the label <b>02</b> in Picture 1 below.</li> <li>(3) Replace the primary lock in accordance with the instructions defined in Airbus Service Bulletin (SB) A340-78-4037,<br/>and<br/>Remove the installed shim and replace the actuator in accordance with the instructions defined in Airbus SB A340-78-4038.</li> </ol> <p style="text-align: center;">Picture 1</p> |
