| <b>EASA</b> | <b>AIRWORTHINESS DIRECTIVE</b> |
| | <p><b>AD No.: 2010-0044</b><br/> <b>[Correction: 25 March 2010]</b></p> <p><b>Date: 17 March 2010</b></p> <p>Note: This Airworthiness Directive (AD) is issued by EASA, acting in accordance with Regulation (EC) No 216/2008 on behalf of the European Community, its Member States and of the European third countries that participate in the activities of EASA under Article 66 of that Regulation.</p> |
| <b>Type Approval Holder's Name :</b><br>AIRBUS | <b>Type/Model designation(s) :</b><br>A340-200/-300 aeroplanes |
| <b>ATA 78</b> | <b>Exhaust – Thrust Reverser Actuation System Doors – Replacement</b> |

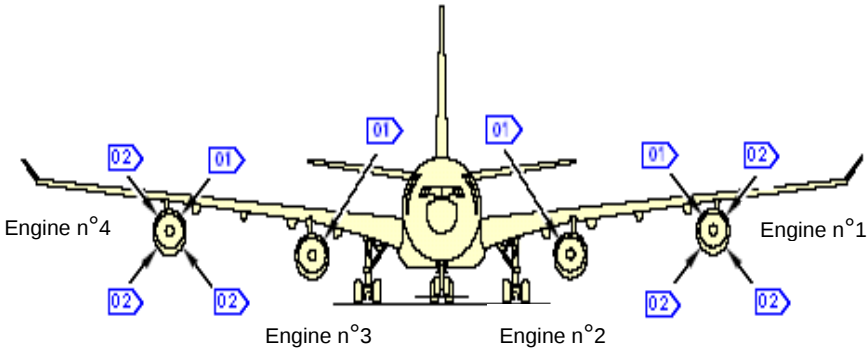
| | This AD correction is issued to amend the engines numbering in Picture 1 of the "Required action and Compliance Time" section of this AD. |
| Required action(s) and Compliance Time(s): | <p>Required as indicated, unless accomplished previously:</p> <ol style="list-style-type: none"> <li>(1) No later than 28 February 2011, do the actions specified in paragraph (3) of this AD on the upper inboard thrust reverser pivoting door of each engine, as identified by the label <b>01</b> in Picture 1 below.</li> <li>(2) No later than 31 December 2012, do the actions specified in paragraph (3) of this AD on the upper outboard thrust reverser pivoting doors of engines n°1 and n°4, and lower thrust reverser pivoting doors (inboard and outboard) of engines n°1 and n°4 as identified by the label <b>02</b> in Picture 1 below.</li> <li>(3) Replace the primary lock in accordance with the instructions defined in Airbus Service Bulletin (SB) A340-78-4037, and<br/>Remove the installed shim and replace the actuator in accordance with the instructions defined in Airbus SB A340-78-4038.</li> </ol> <p style="text-align: center;">Picture 1</p> |
