| <b>EASA</b> | <b>AIRWORTHINESS DIRECTIVE</b> |
| | <p><b>AD No.: 2010-0248</b></p> <p><b>Date: 26 November 2010</b></p> <p>Note: This Airworthiness Directive (AD) is issued by EASA, acting in accordance with Regulation (EC) No 216/2008 on behalf of the European Community, its Member States and of the European third countries that participate in the activities of EASA under Article 66 of that Regulation.</p> |
| <p><b>Type Approval Holder's Name :</b></p> <p>Eurocopter Deutschland GmbH</p> | <p><b>Type/Model designation(s) :</b></p> <p>MBB-BK 117 C-2 helicopters</p> |
| <b>ATA 67</b> | <b>Rotor Flight Controls – Main Rotor Controls Power Boosted Section – Inspection / Rigging</b> |

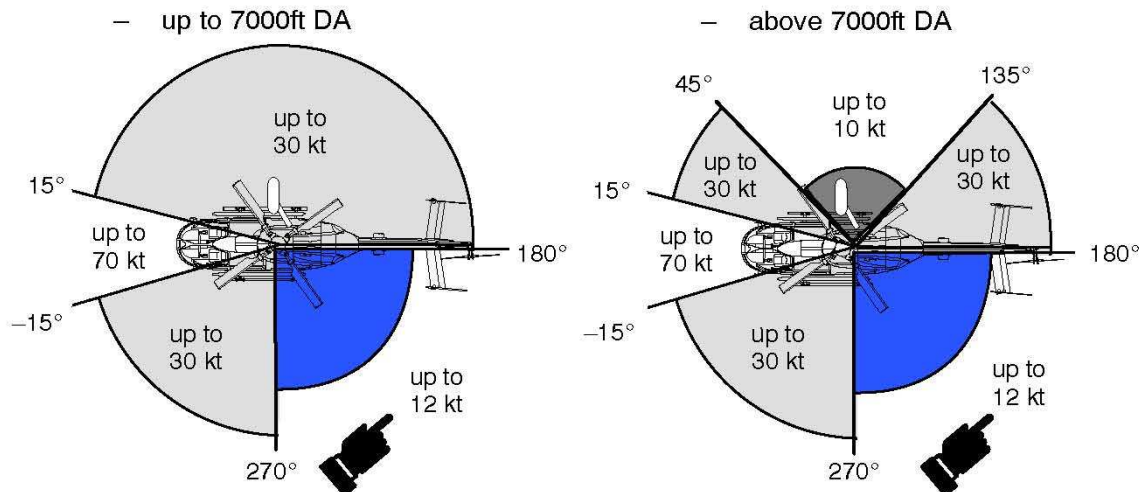
**EFFECTIVITY** *External Hoist System (RH) installed.*

Hoist operations have been demonstrated under the following conditions:

The following information must be added to RFM Supplement 9.2-11:
