EASA	AIRWORTHINESS DIRECTIVE

<p>AD No.: 2011-0006</p> <p>Date: 17 January 2011</p> <p>Note: This Airworthiness Directive (AD) is issued by EASA, acting in accordance with Regulation (EC) No 216/2008 on behalf of the European Community, its Member States and of the European third countries that participate in the activities of EASA under Article 66 of that Regulation.</p>
This AD is issued in accordance with EC 1702/2003, Part 21A.3B. In accordance with EC 2042/2003 Annex I, Part M.A.301, the continuing airworthiness of an aircraft shall be ensured by accomplishing any applicable ADs. Consequently, no person may operate an aircraft to which an AD applies, except in accordance with the requirements of that AD unless otherwise specified by the Agency [EC 2042/2003 Annex I, Part M.A.303] or agreed with the Authority of the State of Registry [EC 216/2008, Article 14(4) exemption].	
Type Approval Holder's Name :	Type/Model designation(s) :

AIRBUS	A300, A310, A300-600 and A300-600ST aeroplanes
TCDS Number :	France No.145 and EASA.A.014
Foreign AD :	Not applicable
Supersedure :	None
ATA 29	Hydraulic Power – Hydraulic Accumulator – Inspection / Replacement / Placards Installation
Manufact

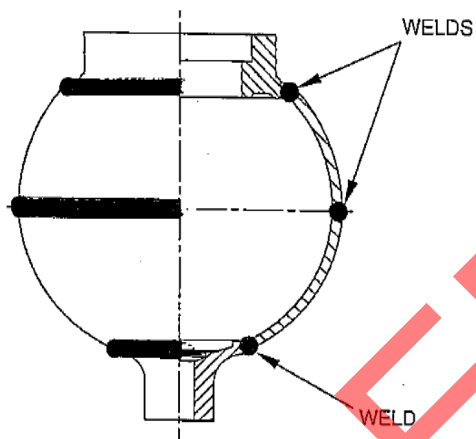
OLD DESIGN

HYDRAULIC ACCUMULATOR : designed with 4 parts and 3 welds

<p>(2) If, during the visual inspection as required by paragraph (1) of this AD, an old design hydraulic accumulator is found installed on any of the affected hydraulic circuits as indicated in Table 1 of this AD, as applicable to aeroplane model, replace each affected old design accumulator with a new design accumulator in accordance with the instructions of Airbus SB A300-29-0126 Revision 01, SB A310-29-2099, SB A300-29-6063, or SB A300-29-9012, as applicable to aeroplane model.</p> <p>(3) Irrespective of findings during the visual inspection as required by paragraph (1) of this AD, install placards at the designated locations of the affected hydraulic circuits indicated in Table 1 of this AD, as applicable to aeroplane model, in accordance with the instructions of Airbus SB A300-29-0127, SB A310-29-2100, SB A300-29-6064, or SB A300-29-9013, as applicable to aeroplane model.</p>	Affected Aeroplanes	Affected Hydraulic Circuit(s)	A300 PRE mod 02447	Blue and Green	A300 POST mod 2447	Blue	A300-600 and A300F4-608ST	Blue	A310	Green
Affected Aeroplanes	Affected Hydraulic Circuit(s)										
A300 PRE mod 02447	Blue and Green										
A300 POST mod 2447	Blue										
A300-600 and A300F4-608ST	Blue										
A310	Green										
Ref. Publications:	<p>Airbus SB A300-29-0126 Revision 01 and SB A300-29-0127 original issue.</p> <p>Airbus SB A310-29-2099 and SB A310-29-2100, both original issue.</p> <p>Airbus SB A300-29-6063 and SB A300-29-6064, both original issue.</p> <p>Airbus SB A300-29-9012 and SB A300-29-9013, both original issue.</p> <p>The use of later approved revisions of these documents is acceptable for compliance with the requirements of this AD.</p>										
Remarks :	<ol style="list-style-type: none"> If requested and appropriately substantiated, EASA can approve Alternative Methods of Compliance for this AD. This AD was posted on 15 December 2010 as PAD 10-122 for consultation until 12 January 2011. The Comment Response Document can be found at http://ad.easa.europa.eu/. Enquiries regarding this AD should be referred to the Airworthiness Directives, Safety Management & Research Section, Certification Directorate, EASA E-mail: ADs@easa.europa.eu. For any question concerning the technical content of the requirements in this AD, please contact: AIRBUS SAS – EAW (Airworthiness Office, Telephone: + 33 5 61 93 36 96, Fax: + 33 5 61 93 44 51).

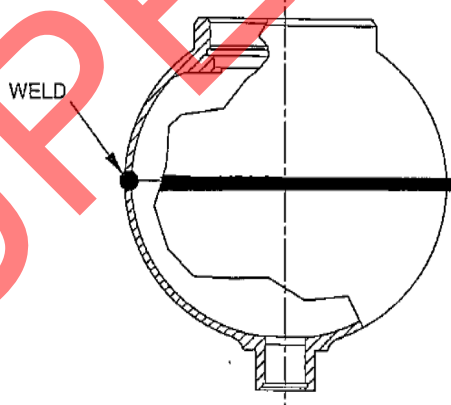
NEW DESIGN

HYDRAULIC ACCUMULATOR : designed with 2 parts and 1 weld
