EASA	NOTIFICATION OF A PROPOSAL TO ISSUE AN AIRWORTHINESS DIRECTIVE

<p>PAD No.: 10-122</p> <p>Date: 15 December 2010</p> <p>Note: This Proposed Airworthiness Directive (PAD) is issued by EASA, acting in accordance with Regulation (EC) No 216/2008 on behalf of the European Community, its Member States and of the European third countries that participate in the activities of EASA under Article 66 of that Regulation.</p>
In accordance with the EASA Continuing Airworthiness Procedures, the Executive Director is proposing the issuance / cancellation of an EASA Airworthiness Directive (AD), applicable to the aeronautical product(s) identified below. All interested persons may send their comments, referencing the PAD Number above, to the e-mail address specified in the 'Remarks' section, prior to the consultation closing date indicated.	
Type Approval Holder's Name : AIRBUS	Type/Model designation(s) : A300, A310, A300-600 and A300-600ST aeroplanes

TCDS Number : France No.145 and EASA.A.014	
Foreign AD : Not applicable	
Supersedure : None	
ATA 29	Hydraulic Power – Hydraulic Accumulator – Inspection / Replacement / Placards Installation
Manufacturer(s):	Airbus (formerly Airbus Industrie)

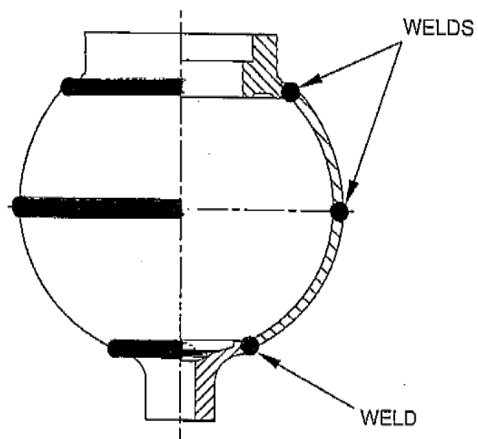
OLD DESIGN

HYDRAULIC ACCUMULATOR : designed with 4 parts and 3 welds

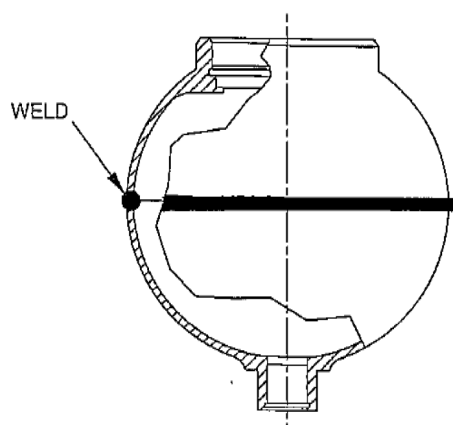
NEW DESIGN

HYDRAULIC ACCUMULATOR : designed with 2 parts and 1 weld
