EASA	COMMENT RESPONSE DOCUMENT

EASA PAD No. 11-084 [Published on 10 August 2011 and officially closed for comments on 07 September 2011]

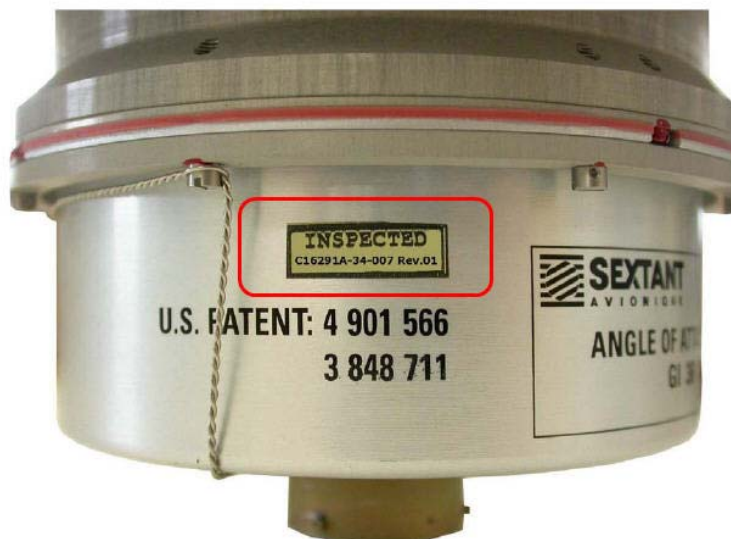
Figure 3

According to EASA PAD No.11-084 Compliance paragraph (1), replace the affected AOA which listed in VSB C16291A-34-007R1, unless it has Amend "E" marking. But, according to VSB C16291A-34-007R1, [if] the AOA had been inspected in according to this VSB, a specific label (Refer to Figure 3) is marked.

Could you please confirm there is Amend "E" marking in place of Inspected Label on the Post VSB AOA?

Inspection label position PNR F1317654

Comment accepted. VSB C16291A-34-007 Rev00 covered the Amendment E which was a simple test at -55°C. This was finally deemed inadequate. Consequently, any probe having Amendment E, but listed in VSB C16291A-34-007 Rev01 needs to be removed. Thus, the wording “unless it has the marking “E” recorded on its amendment plate” has been removed from the Final AD text.
