EASA	NOTIFICATION OF A PROPOSAL TO ISSUE AN AIRWORTHINESS DIRECTIVE

<p>PAD No.: 12-098</p> <p>Date: 31 July 2012</p> <p>Note: This Proposed Airworthiness Directive (PAD) is issued by EASA, acting in accordance with Regulation (EC) No 216/2008 on behalf of the European Community, its Member States and of the European third countries that participate in the activities of EASA under Article 66 of that Regulation.</p>
<p>In accordance with the EASA Continuing Airworthiness Procedures, the Executive Director is proposing the issuance of an EASA Airworthiness Directive (AD), applicable to the aeronautical product(s) identified below. All interested persons may send their comments, referencing the PAD Number above, to the e-mail address specified in the 'Remarks' section, prior to the consultation closing date indicated.</p>	
Design Approval Holder's Name: ATR-GIE Avions de Transport Régional	Type/Model designation(s): ATR 72-212A aeroplanes

TCDS Number:	EASA A.084
Foreign AD:	Not applicable
Supersedure:	None
ATA 54	Nacelles and Pylons – Engine Shock Mount Pick-up Fittings – Inspection / Replacement
Manufacturer(s):	ATR-GIE Avions de Transport Régional (formerly Aerospatiale-Aeritalia,

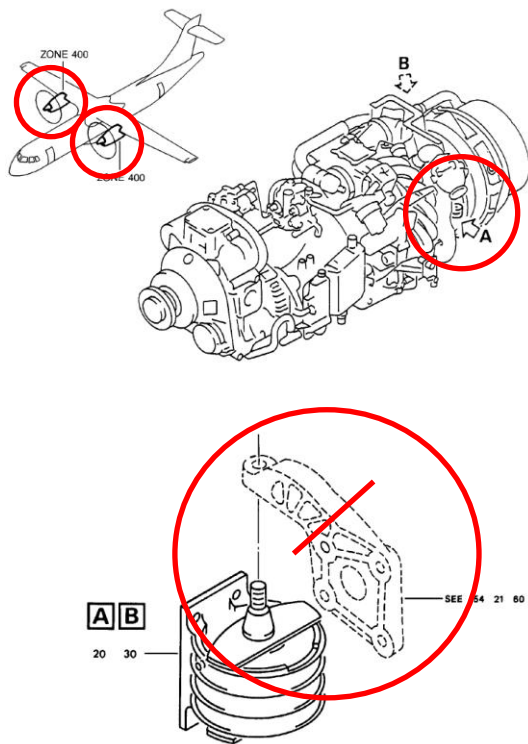
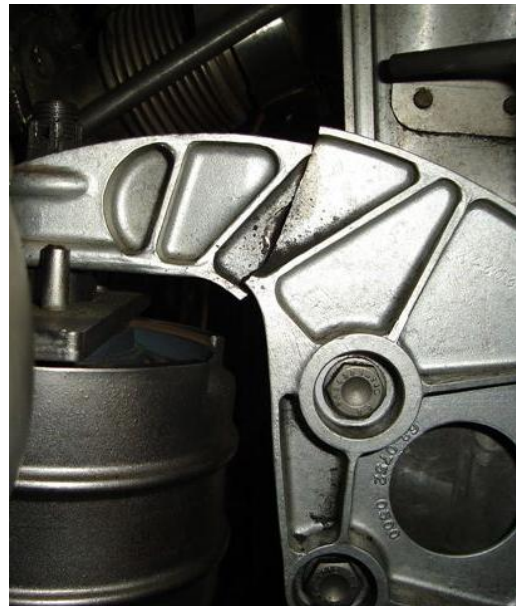
Figure 1: Shock mount pick-up fitting potential failure

Appendix 1 – Location of suspected cracks

<p>Required Action(s) and Compliance Time(s):</p>	<p>Required as indicated, unless already accomplished</p> <p>(1) Within 6 months after the effective date of this AD, accomplish the following actions concurrently:</p> <p>(1.1) Identify the s/n of the P/N S54210394200 LH shock mount pick up fittings installed on both engine nacelles.</p> <p>A review of maintenance records is acceptable to determine the s/n of the LH shock mount pick up fitting, provided the s/n can be conclusively identified from this review.</p> <p>(1.2) Visually inspect both LH and RH aft side isolator pick up fittings on both engines in accordance with the instructions of the applicable Aircraft Maintenance Manual (AMM) Job Instruction Card (JIC) 541161-DVI-10000 paragraph 004.1. Refer to Appendix 1 Figure 1 of this AD for potential crack location.</p> <p>(1.3) Visually inspect both LH and RH aft shock mount cone bolts on both engines in accordance with the instructions of the applicable AMM JIC 712000-DVI-10000 paragraph 006.3.A. Refer to Appendix 1 Figure 2 of this AD for potential crack location.</p> <p>(2) If, during any inspection as required by paragraphs (1.2) or (1.3) of this AD, cracks are detected, before next flight, contact ATR to get approved replacement instructions and apply them accordingly within the compliance time specified in those instructions.</p> <p>(3) If the s/n of the L/H shock mount pick up fitting, identified as required by paragraph (1.1) of this AD, is lower than 2451 or unreadable, and no crack has been found, within 6 months after the inspection as required by paragraph (1.2) of this AD, replace LH shock mount pick up fitting P/N S54210394200 with a serviceable LH shock mount pick up fitting having a s/n equal to or higher than 2451, in accordance with ATR approved replacement instructions.</p> <p>(4) Within 30 days after the inspections as required by paragraph 1 of this AD, report all findings (including none) to ATR, by using the reporting form provided in Appendix 2 of this AD.</p> <p>(5) From the effective date of this AD, do not install on any aeroplane a LH shock mount pick up fitting P/N S54210394200, unless it has been determined to have a s/n equal to or higher than 2451.</p>
