EASA	COMMENT RESPONSE DOCUMENT

<p align="center">EASA PAD No. 12-098 [Published on 31 July 2012 and officially closed for comments on 21 August 2012]</p>

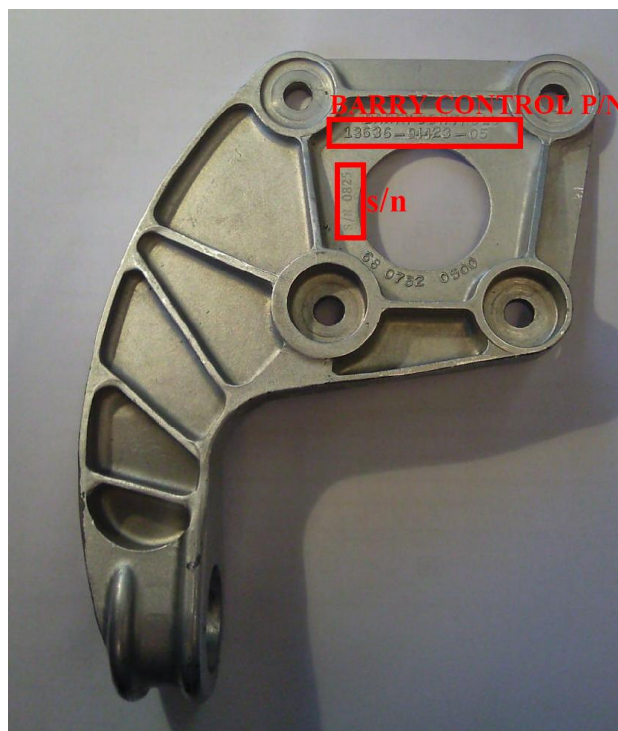
EASA has been informed that the fitting has been improved through a supplier amendment only; no aircraft Modification and no new P/N corresponds to this improved fitting. ATR are unable to determine from which aircraft MSN the new fitting has been installed in production.

The picture below highlights the areas where the fitting data quoted through the PAD can be found. This picture is also reproduced in the Final AD.
