EASA	AIRWORTHINESS DIRECTIVE

AD No.: 2012-0192 Date: 21 September 2012 Note: This Airworthiness Directive (AD) is issued by EASA, acting in accordance with Regulation (EC) No 216/2008 on behalf of the European Community, its Member States and of the European third countries that participate in the activities of EASA under Article 66 of that Regulation.
This AD is issued in accordance with EC 1702/2003, Part 21A.3B. In accordance with EC 2042/2003 Annex I, Part M.A.301, the continuing airworthiness of an aircraft shall be ensured by accomplishing any applicable ADs. Consequently, no person may operate an aircraft to which an AD applies, except in accordance with the requirements of that AD, unless otherwise specified by the Agency [EC 2042/2003 Annex I, Part M.A.303] or agreed with the Authority of the State of Registry [EC 216/2008, Article 14(4) exemption].	
Design Approval Holder's Name: ATR-GIE Avions de Transport Régional	Type/Model designation(s): ATR 72-212A aeroplanes

TCDS Number:	EASA A.084
Foreign AD:	Not applicable
Supersedure:	None
ATA 54	Nacelles and Pylons – Engine Shock Mount Pick-up Fittings – Inspection / Replacement
Manufacturer(s):	ATR-GIE Avions de Transport Ré

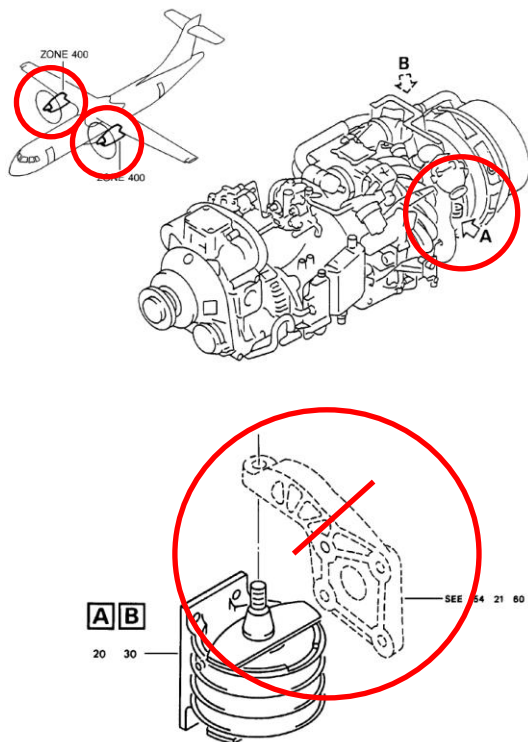
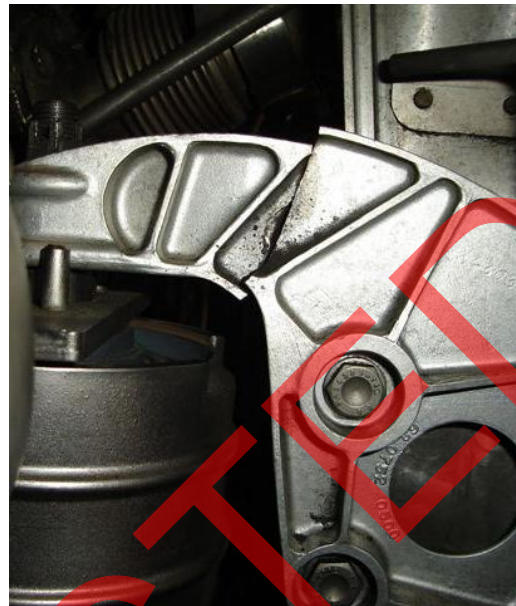
Figure 1: Shock mount pick-up fitting potential failure

Appendix 1 – Location of suspected cracks

<p>Required Action(s) and Compliance Time(s):</p>	<p>Required as indicated, unless already accomplished</p> <p>(1) Within 6 months after the effective date of this AD, accomplish the following actions concurrently:</p> <p>(1.1) Identify the s/n of the P/N S54210394200 (Barry Control P/N 94423-05) LH and RH shock mount pick-up fittings installed on both engine nacelles. Appendix 2 of this AD identifies the fitting P/N and s/n locations.</p> <p>A review of maintenance records is acceptable to determine the s/n of the LH and RH shock mount pick-up fitting, provided the s/n can be conclusively identified from this review.</p> <p>(1.2) Visually inspect both LH and RH aft side isolator pick-up fittings on both engines in accordance with the instructions of the applicable Aircraft Maintenance Manual (AMM) Job Instruction Card (JIC) 541161-DVI-10000 paragraph 004.1. Refer to Appendix 1 Figure 1 of this AD for potential crack location.</p> <p>(1.3) Visually inspect both LH and RH aft shock mount cone bolts on both engines in accordance with the instructions of the applicable AMM JIC 712000-DVI-10000 paragraph 006.3.A. Refer to Appendix 1 Figure 2 of this AD for potential crack location.</p> <p>(2) If, during any inspection as required by paragraphs (1.2) or (1.3) of this AD, cracks are detected, before next flight, replace defective component in accordance with approved ATR instructions.</p> <p>(3) If the s/n of the L/H shock mount pick-up fitting, identified as required by paragraph (1.1) of this AD, is lower than 2451 or unreadable, and no crack has been found, within 6 months after the inspection as required by paragraph (1.2) of this AD, replace LH shock mount pick-up fitting P/N S54210394200 with a serviceable LH shock mount pick-up fitting having a s/nequal to or higher than 2451, in accordance with ATR approved instructions.</p> <p>(4) Within 30 days after the inspections as required by paragraph 1 of this AD, report all findings (including none) to ATR, by using the reporting form provided in Appendix 3 of this AD.</p> <p>(5) From the effective date of this AD, do not install on any aeroplane a LH shock mount pick-up fitting P/N S54210394200, unless it has been determined to have a s/nequal to or higher than 2451.</p>

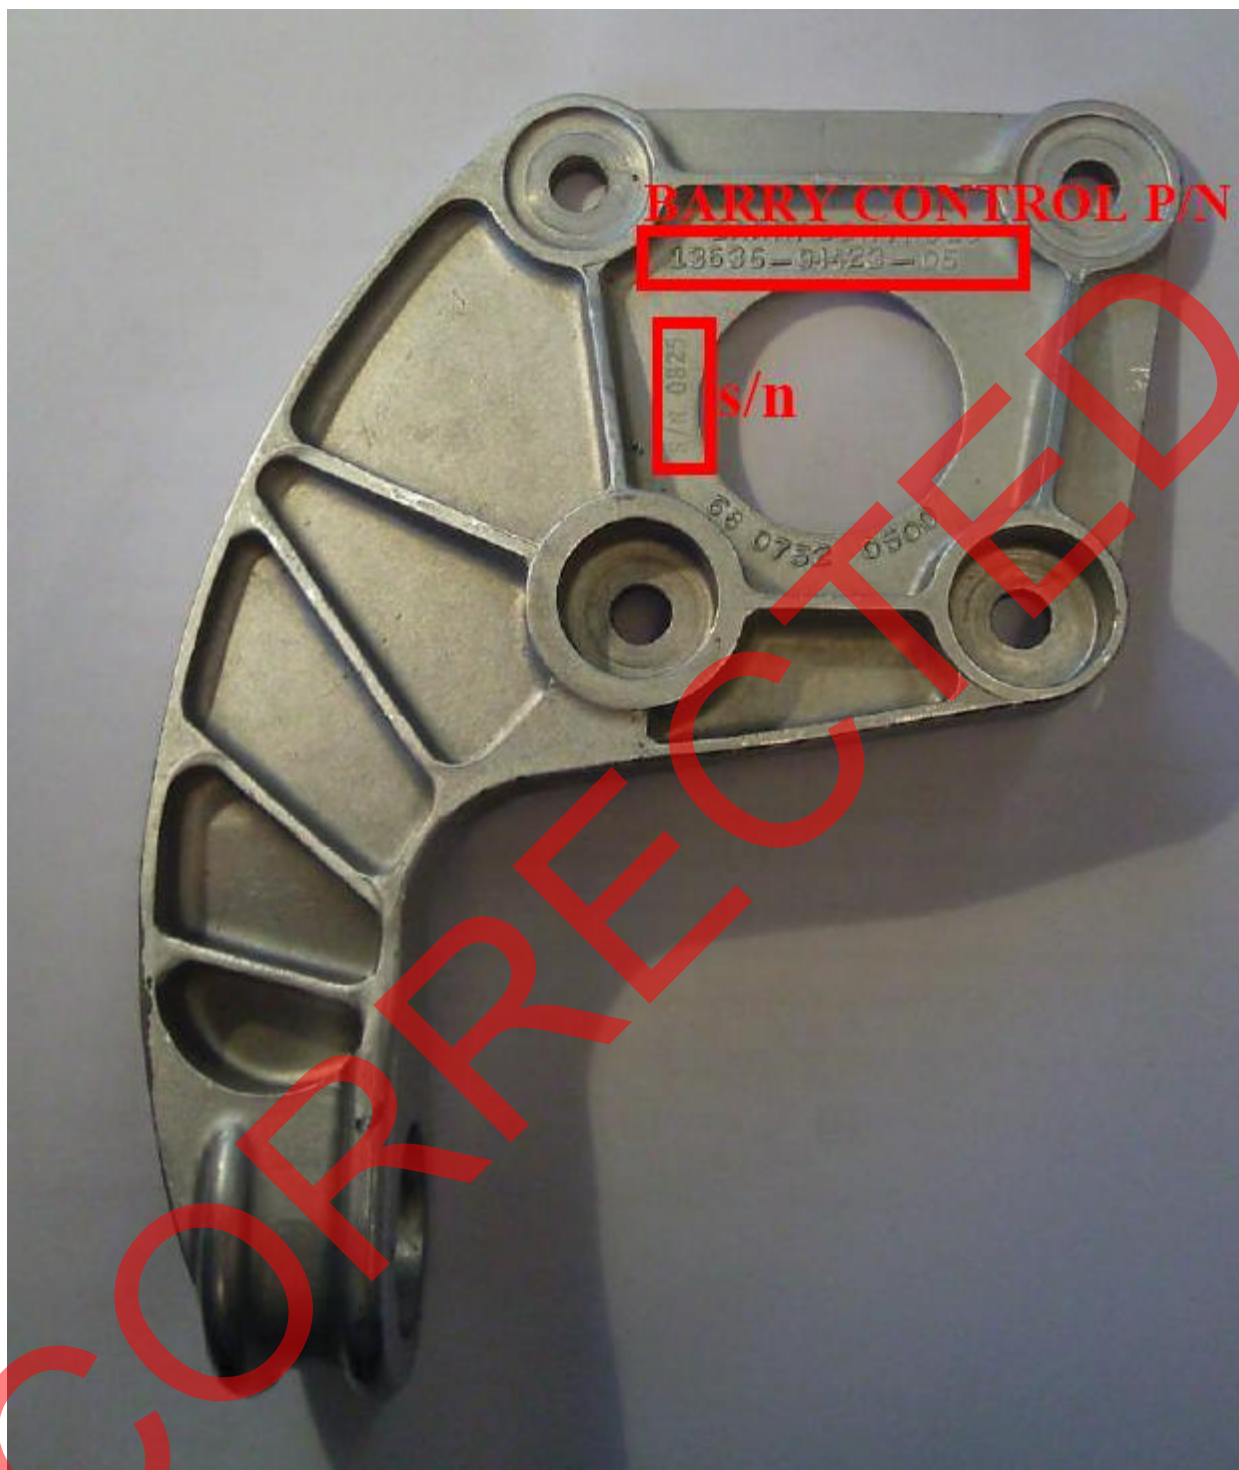
Figure 3: Location of Fitting P/N and s/n

Appendix 2 – Identification of affected Fittings

Reminder: if pick-up fitting s/n is below 2451, the pick-up fitting must be replaced
