<b>EASA</b>	<b>AIRWORTHINESS DIRECTIVE</b>
 	<p><b>AD No.: 2014-0018R1</b></p> <p><b>Date: 20 January 2014</b></p> <p>Note: This Airworthiness Directive (AD) is issued by EASA, acting in accordance with Regulation (EC) No 216/2008 on behalf of the European Community, its Member States and of the European third countries that participate in the activities of EASA under Article 66 of that Regulation.</p>
<p>This AD is issued in accordance with EU 748/2012, Part 21.A.3B. In accordance with EC 2042/2003 Annex I, Part M.A.301, the continuing airworthiness of an aircraft shall be ensured by accomplishing any applicable ADs. Consequently, no person may operate an aircraft to which an AD applies, except in accordance with the requirements of that AD, unless otherwise specified by the Agency [EC 2042/2003 Annex I, Part M.A.303] or agreed with the Authority of the State of Registry [EC 216/2008, Article 14(4) exemption].</p>

<p><b>Design Approval Holder's Name :</b></p> <p>AIRBUS</p>	<p><b>Type/Model designation(s) :</b></p> <p>A300, A300-600, A300-600ST and A310 aeroplanes</p>
<p>TCDS Numbers : France No. 145 and EASA.A.014</p>	
<p>Foreign AD : None</p>	
<p>Revision: This AD revises EASA A

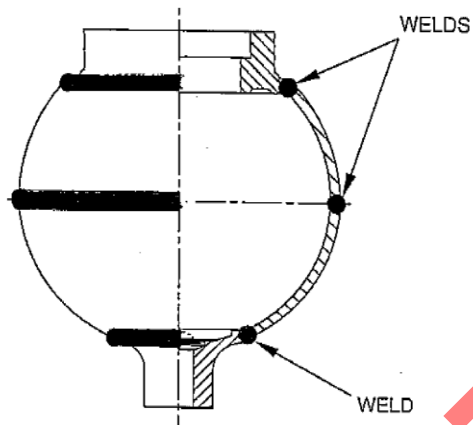
**OLD DESIGN**

**HYDRAULIC ACCUMULATOR** : designed with 4 parts and 3 welds

<p>(1.2) If, during the visual inspection as required by paragraph (1.1) of this AD, an old design hydraulic accumulator is found installed on any of the affected hydraulic circuits as indicated in Table 1 of this AD, as applicable to aeroplane model, replace each affected old design accumulator with a new design accumulator in accordance with the instructions of Airbus SB A300-29-0126 Revision 01, SB A310-29-2099, SB A300-29-6063, or SB A300-29-9012, as applicable to aeroplane model.</p> <p>(1.3) Irrespective of findings during the visual inspection as required by paragraph (1.1) of this AD, install placards at the designated locations of the affected hydraulic circuits indicated in Table 1 of this AD, as applicable to aeroplane model, in accordance with the instructions of Airbus SB A300-29-0127, SB A310-29-2100, SB A300-29-6064, or SB A300-29-9013, as applicable to aeroplane model.</p>	Affected aeroplanes	Affected hydraulic circuit(s)	A300, without Airbus Modification (Mod) 02447 embodied in production	Blue and Green	A300, with Airbus Mod 02447 embodied in production	Blue	A300-600 and A300F4-608ST	A310	Green
Affected aeroplanes	Affected hydraulic circuit(s)									
A300, without Airbus Modification (Mod) 02447 embodied in production	Blue and Green									
A300, with Airbus Mod 02447 embodied in production	Blue									
A300-600 and A300F4-608ST										
A310	Green

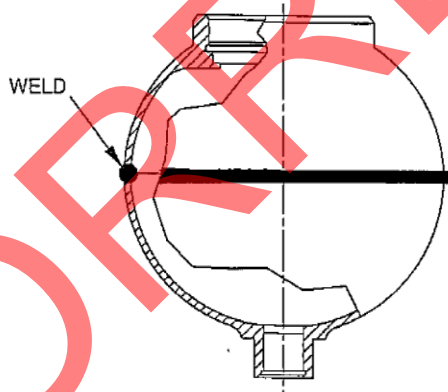
**NEW DESIGN**

**HYDRAULIC ACCUMULATOR** : designed with 2 parts and 1 weld
