<b>EASA</b>	<b>NOTIFICATION OF A PROPOSAL TO ISSUE AN AIRWORTHINESS DIRECTIVE</b>

<p><b>PAD No.: 13-118R1</b></p> <p><b>Date: 23 September 2013</b></p> <p>Note: This Proposed Airworthiness Directive (PAD) is issued by EASA, acting in accordance with Regulation (EC) No 216/2008 on behalf of the European Community, its Member States and of the European third countries that participate in the activities of EASA under Article 66 of that Regulation.</p>
<p>In accordance with the EASA Continuing Airworthiness Procedures, the Executive Director is proposing the issuance of an EASA Airworthiness Directive (AD), applicable to the aeronautical product(s) identified below. All interested persons may send their comments, referencing the PAD Number above, to the e-mail address specified in the 'Remarks' section, prior to the consultation closing date indicated.</p>	
<p><b>Type Approval Holder's Name :</b></p> <p>AIRBUS</p>	<p><b>Type/Model designation(s) :</b></p> <p>A300, A300-600, A300-600ST and A310 aeroplanes</p>

<p>TCDS Numbers : France No. 145 and EASA.A.014</p>	
<p>Foreign AD : None</p>	
<p>Supersedure : This AD supersedes EASA AD 2011-0006 dated 17 January 2011.</p>	
<b>ATA 29</b>	<b>

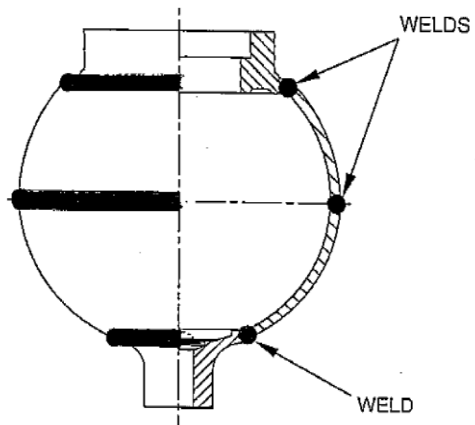
**OLD DESIGN**

**HYDRAULIC ACCUMULATOR** : designed with 4 parts and 3 welds

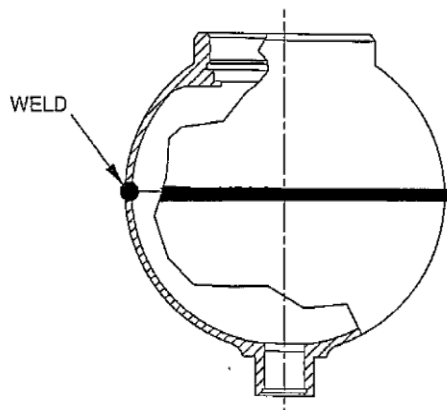
**NEW DESIGN**

**HYDRAULIC ACCUMULATOR** : designed with 2 parts and 1 weld
