EASA	NOTIFICATION OF A PROPOSAL TO ISSUE AN AIRWORTHINESS DIRECTIVE

<p>PAD No.: 13-118</p> <p>Date: 15 August 2013</p> <p>Note: This Proposed Airworthiness Directive (PAD) is issued by EASA, acting in accordance with Regulation (EC) No 216/2008 on behalf of the European Community, its Member States and of the European third countries that participate in the activities of EASA under Article 66 of that Regulation.</p>
<p>In accordance with the EASA Continuing Airworthiness Procedures, the Executive Director is proposing the issuance of an EASA Airworthiness Directive (AD), applicable to the aeronautical product(s) identified below. All interested persons may send their comments, referencing the PAD Number above, to the e-mail address specified in the 'Remarks' section, prior to the consultation closing date indicated.</p>	
Type Approval Holder's Name : AIRBUS	Type/Model designation(s) : A300, A300-600, A300-600ST and A310 aeroplanes

TCDS Numbers : France No. 145 and EASA.A.014	
Foreign AD : None	
Supersedure : This AD supersedes EASA AD 2011-0006 dated 17 January 2011.	
ATA 29	Hydraulic Power – Hydraulic Accumulator – Inspection / Replacement / Placards Installation
Manufacturer(s)

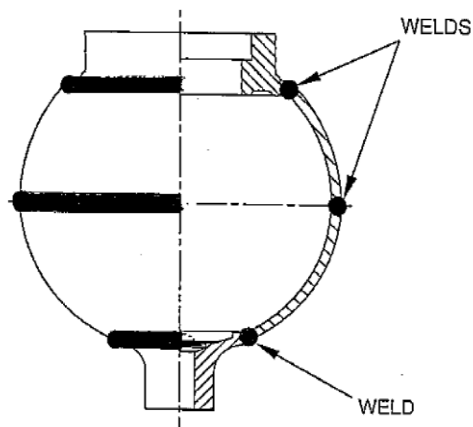
OLD DESIGN

HYDRAULIC ACCUMULATOR : designed with 4 parts and 3 welds

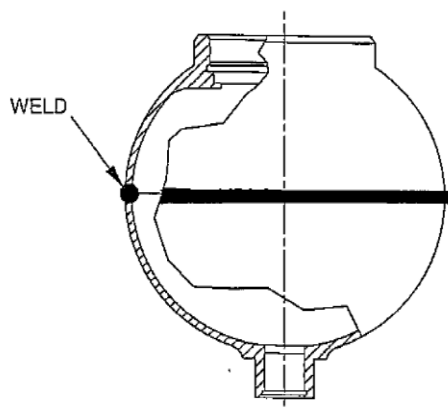
NEW DESIGN

HYDRAULIC ACCUMULATOR : designed with 2 parts and 1 weld
