<b>EASA</b>	<b>AIRWORTHINESS DIRECTIVE</b>
 	<p><b>AD No.: 2014-0018</b></p> <p><b>Date: 16 January 2014</b></p> <p>Note: This Airworthiness Directive (AD) is issued by EASA, acting in accordance with Regulation (EC) No 216/2008 on behalf of the European Community, its Member States and of the European third countries that participate in the activities of EASA under Article 66 of that Regulation.</p>
<p>This AD is issued in accordance with EU 748/2012, Part 21.A.3B. In accordance with EC 2042/2003 Annex I, Part M.A.301, the continuing airworthiness of an aircraft shall be ensured by accomplishing any applicable ADs. Consequently, no person may operate an aircraft to which an AD applies, except in accordance with the requirements of that AD, unless otherwise specified by the Agency [EC 2042/2003 Annex I, Part M.A.303] or agreed with the Authority of the State of Registry [EC 216/2008, Article 14(4) exemption].</p>

<p><b>Design Approval Holder's Name :</b></p> <p>AIRBUS</p>	<p><b>Type/Model designation(s) :</b></p> <p>A300, A300-600, A300-600ST and A310 aeroplanes</p>
<p>TCDS Numbers : France No. 145 and EASA.A.014</p>	
<p>Foreign AD : None</p>	
<p>Supersedure : This AD supersedes E

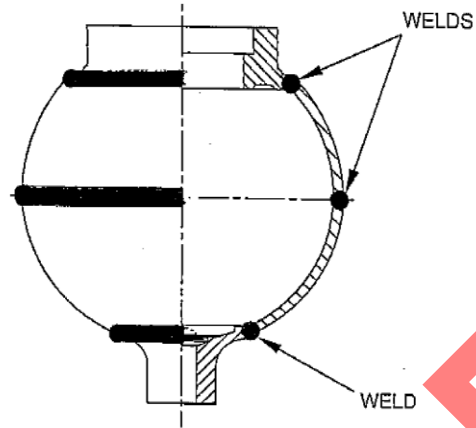
**OLD DESIGN**

**HYDRAULIC ACCUMULATOR** : designed with 4 parts and 3 welds

<p>(1.2) If, during the visual inspection as required by paragraph (1.1) of this AD, an old design hydraulic accumulator is found installed on any of the affected hydraulic circuits as indicated in Table 1 of this AD, as applicable to aeroplane model, replace each affected old design accumulator with a new design accumulator in accordance with the instructions of Airbus SB A300-29-0126 Revision 01, SB A310-29-2099, SB A300-29-6063, or SB A300-29-9012, as applicable to aeroplane model.</p> <p><b>New requirements of this AD:</b></p> <p>(1.3) Irrespective of findings during the visual inspection as required by paragraph (1.1) of this AD, install placards at the designated locations of the affected hydraulic circuits indicated in Table 1 of this AD, as applicable to aeroplane model, in accordance with the instructions of Airbus SB A300-29-0127 Revision 01, SB A310-29-2100 Revision 01, SB A300-29-6064 Revision 01, or SB A300-29-9013 Revision 01, as applicable to aeroplane model.</p>	Affected aeroplanes	Affected hydraulic circuit(s)	A300, without Airbus Modification (Mod) 02447 embodied in production	Blue and Green	A300, with Airbus Mod 02447 embodied in production	Blue	A300-600 and A300F4-608ST	A310	Green
Affected aeroplanes	Affected hydraulic circuit(s)									
A300, without Airbus Modification (Mod) 02447 embodied in production	Blue and Green									
A300, with Airbus Mod 02447 embodied in production	Blue									
A300-600 and A300F4-608ST										
A310	Green

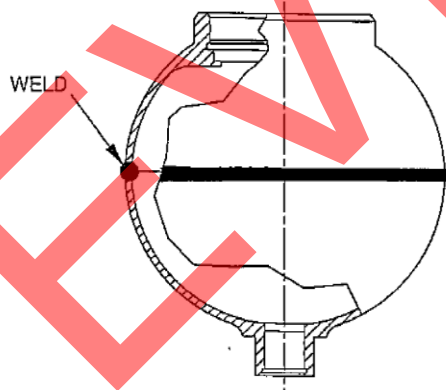
**NEW DESIGN**

**HYDRAULIC ACCUMULATOR** : designed with 2 parts and 1 weld
