<b>EASA</b>	<b>AIRWORTHINESS DIRECTIVE</b>
 	<p><b>AD No.: 2014-0020</b></p> <p><b>Date: 20 January 2014</b></p> <p>Note: This Airworthiness Directive (AD) is issued by EASA, acting in accordance with Regulation (EC) No 216/2008 on behalf of the European Community, its Member States and of the European third countries that participate in the activities of EASA under Article 66 of that Regulation.</p>
<p>This AD is issued in accordance with EU 748/2012, Part 21.A.3B. In accordance with EC 2042/2003 Annex I, Part M.A.301, the continuing airworthiness of an aircraft shall be ensured by accomplishing any applicable ADs. Consequently, no person may operate an aircraft to which an AD applies, except in accordance with the requirements of that AD, unless otherwise specified by the Agency [EC 2042/2003 Annex I, Part M.A.303] or agreed with the Authority of the State of Registry [EC 216/2008, Article 14(4) exemption].</p>

<p><b>Design Approval Holder's Name:</b> VULCANAIR S.p.A.</p>	<p><b>Type/Model designation(s):</b> P.68 aeroplanes</p>
TCDS Number:	EASA.A.385
Foreign AD:	Not applicable
Supersedure:	None
<b>ATA 77</b>	<b>Engine Indicating System – Multifunction Engine Gauge – Inspection

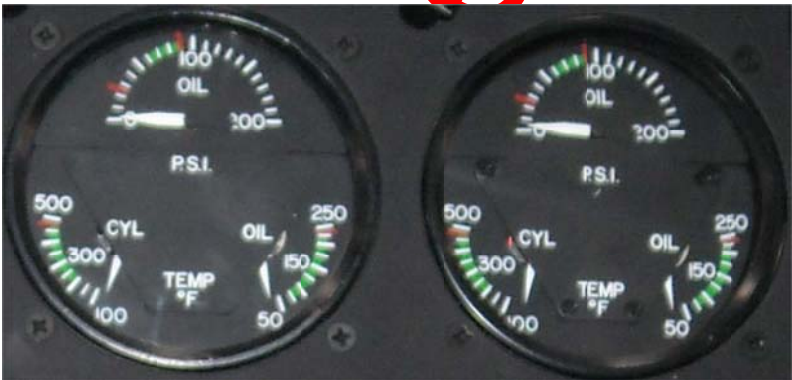
Figure 1. Correct configuration with Weston P/N 22-804-01-19A or A.I.D. P/N 18-1000-11

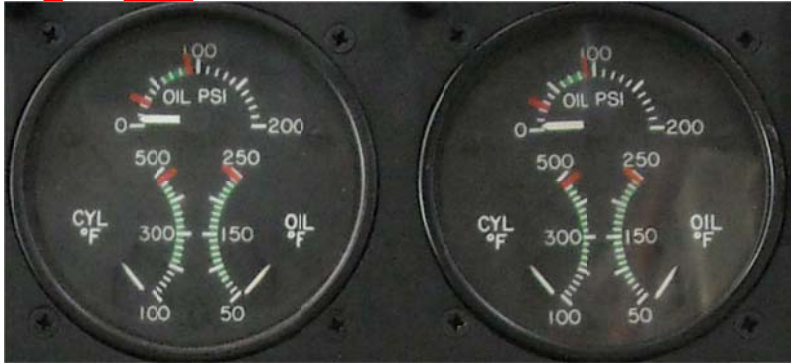
Figure 2. Correct configuration with Sigma Tek (Edo Aire) P/N 1U378-003-20, or P/N 1U378-003-20A
