EASA Safety Information Bulletin

SIB No.:	2012-06R1			
Issued:	07 August 2012

Defective Standard Hardware – MS21042, NAS1291 and LN9338 Self-Locking Nuts, and NAS626 Bolts

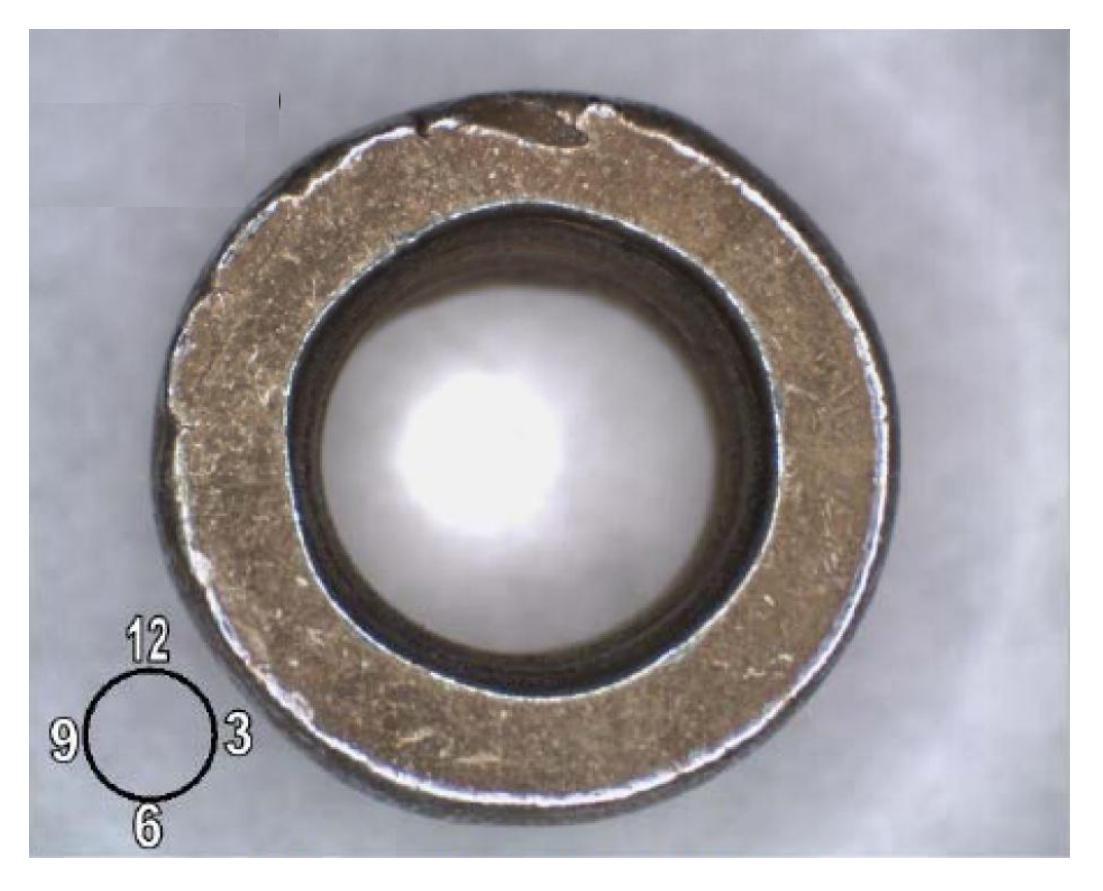
Figure 1: Example of surface irregularities observed on a nut. Overall view.

Recommendation: Manufacturers, aircraft owners, operators and maintenance staff, are recommended to subject the standard hardware (as identified in the Applicability paragraph of this SIB) to a close visual inspection for surface irregularities, such as gouges or cracks, as illustrated in Figures 1 and 2 of this SIB, before being installed on a product.

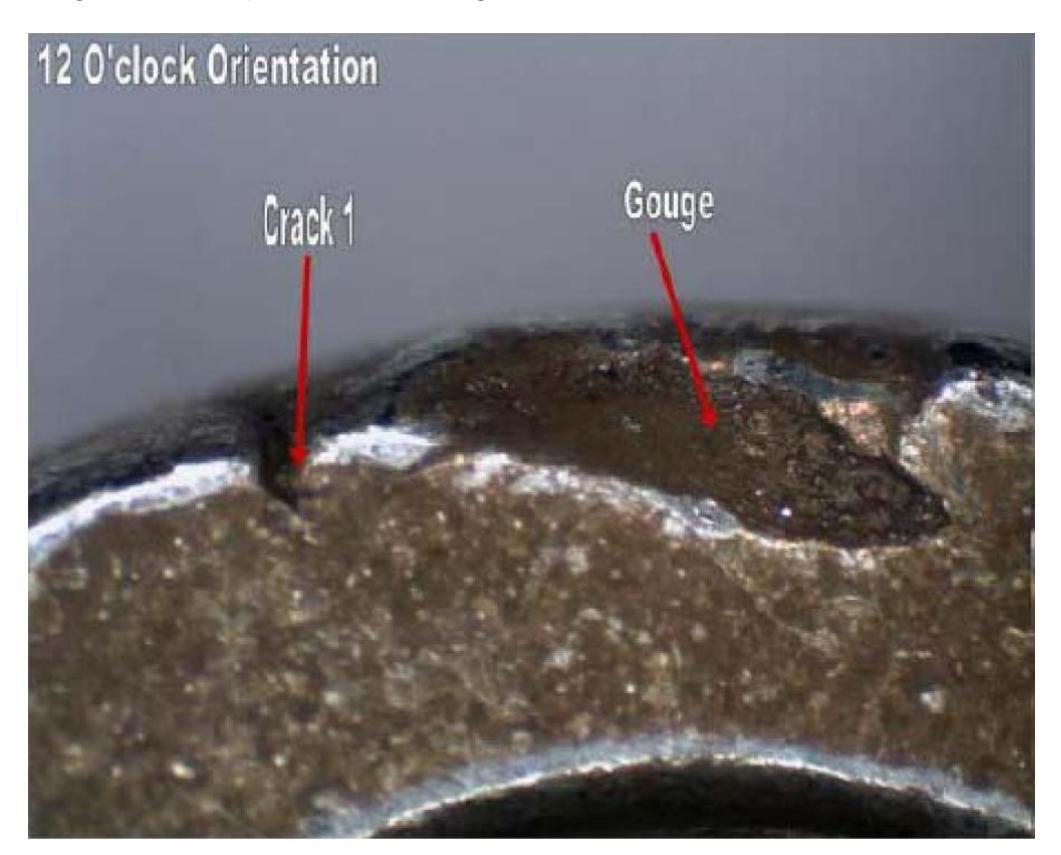
Figure 2: Example of surface irregularities observed on a nut. Detail

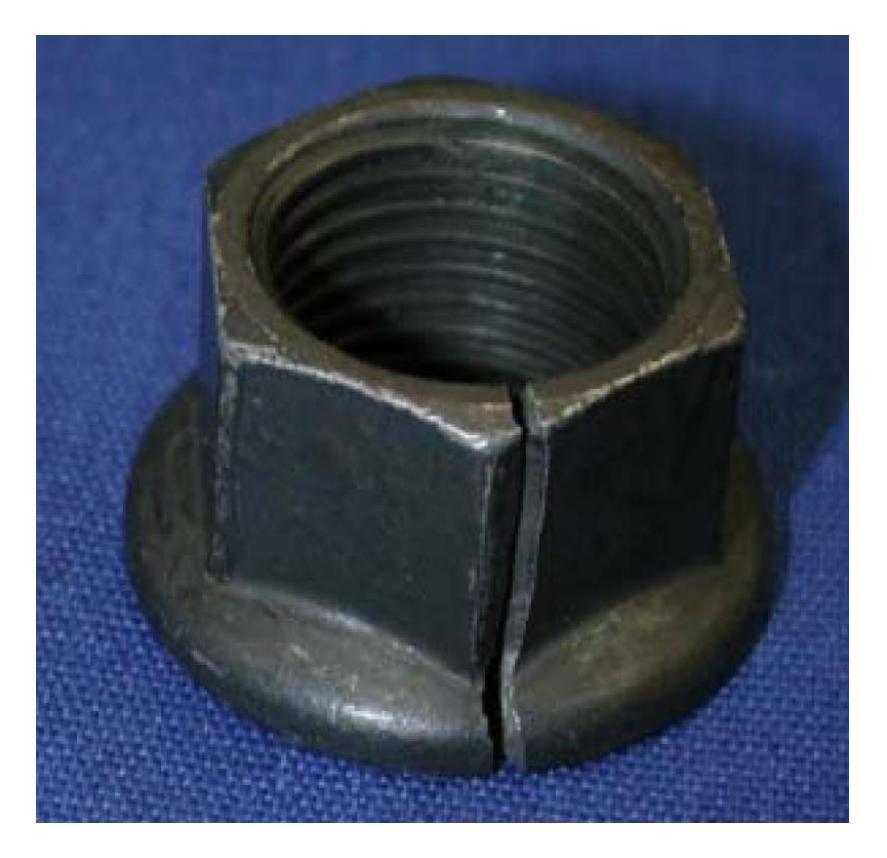
Figure 3: Example of longitudinal crack.

In addition, it is recommended to subject incoming lots of selflocking nuts (as identified in the Applicability paragraph of this SIB) to a torque check and inspection, before receiving them in stock, as follows: Install the nuts on the appropriate bolts, with spacers as required, and keep them torqued (see relevant torque values in Table 1 of this SIB) for 1 week. For statistical reasons, a quantity of 1% (round up) or 20 nuts of one manufactured batch – whichever is less – should be tested. After the test period, visually inspect the nuts for cracks on the bearing surface or longitudinally as illustrated in Figure 3 of this SIB.
