EASA	NOTIFICATION OF A PROPOSAL TO ISSUE AN AIRWORTHINESS DIRECTIVE			
	PAD No.: 14-103			
	Date: 27 June 2014			
<i>E</i>	Regulation (EC) No 216/2008 d	ness Directive (PAD) is issued by EASA, acting in accordance with on behalf of the European Community, its Member States and of the t participate in the activities of EASA under Article 66 of that		
In accordance with the EASA Continuing Airworthiness Procedures, the Executive Director is proposing the issuance of an EASA Airworthiness Directive (AD), applicable to the aeronautical product(s) identified below. All interested persons may send their comments, referencing the PAD Number above, to the e-mail address specified in the 'Remarks' section, prior to the consultation closing date indicated.				
Type Approval Holder's Name :		Type/Model designation(s) :		
AIRBUS		A318, A319, A320 and A321 aeroplanes		
TCDS Number :	EASA.A.064			
Foreign AD : Not applicable

Supersedure: This AD supersedes EASA AD 2012-0055R1 dated 17 October 2012.				
ATA 35 Oxygen – Chemical Emergency Oxygen Containers – Modification				
Manufacturer(s):	Airbus (formerly Airbus Indu	ustrie)		
Applicability:	Airbus A318-111, A318-112, A318-121, A318-122, A319-

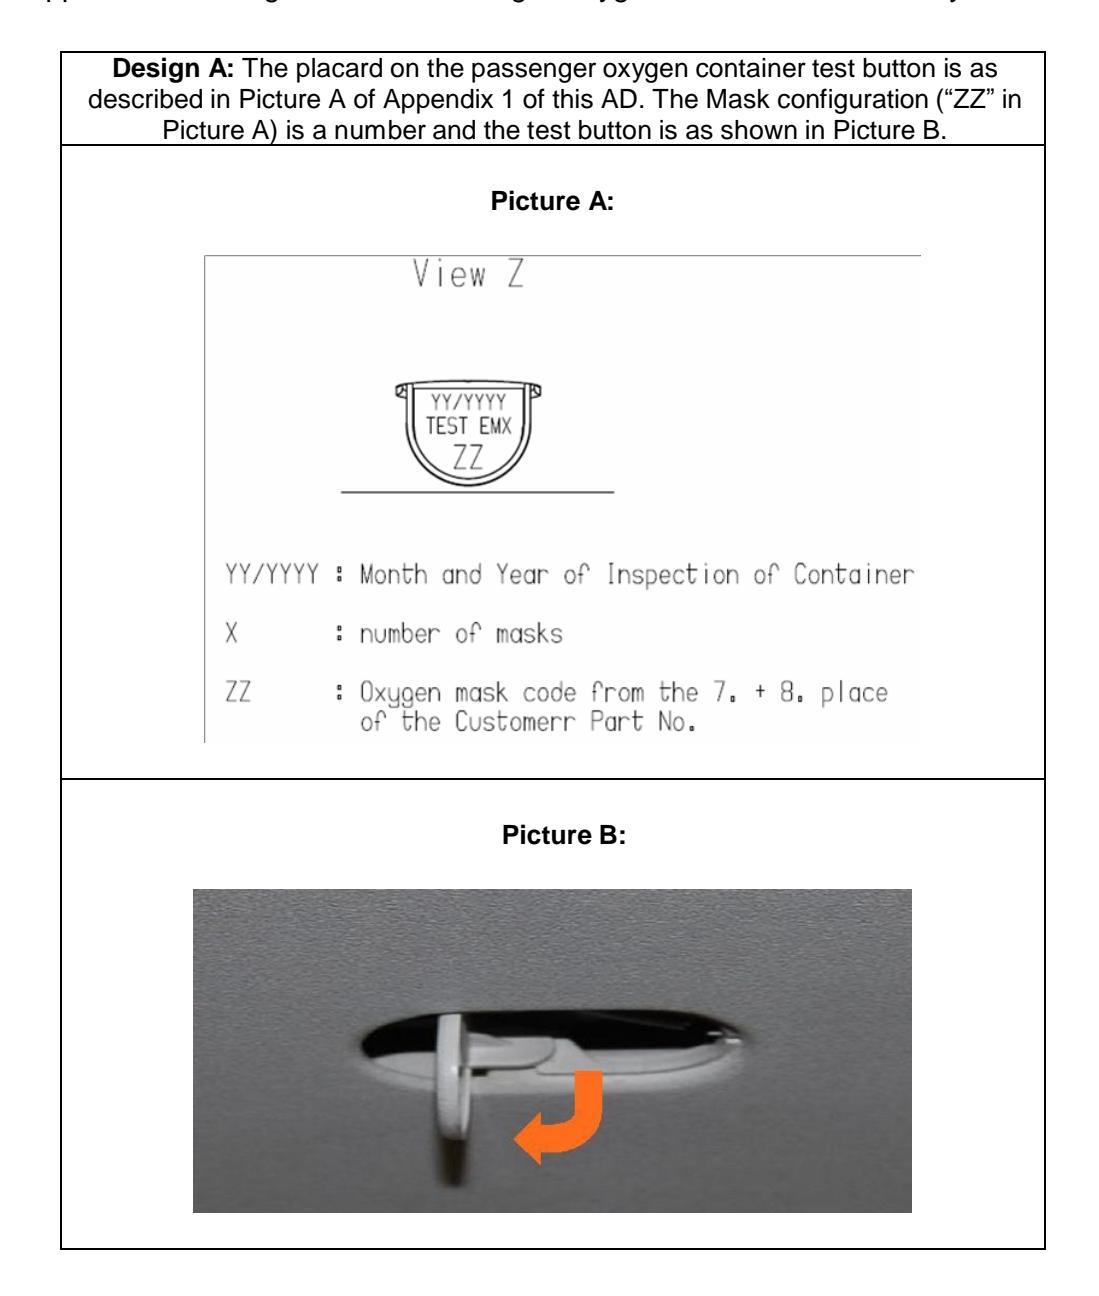
## Appendix 1 – Design A of the Passenger Oxygen Containers affected by this AD

(6) Aeroplanes on which the design of the passenger oxygen container is <u>not</u> Design A as defined in Appendix 1 of this AD, do not have to comply with the requirements of paragraph (1) of this AD for that passenger oxygen container.	
Ref. Publications:	Airbus SB A320-35-1049 original issue dated 15 June 2011. Airbus SB A320-35-1053 original issue dated 15 June 2011. Airbus SB A320-35-1054 original issue dated 15 June 2011. Airbus SB A320-35-1055 original issue dated 15 June 2011. Airbus SB A320-35-1056 original issue dated 15 June 2011. Airbus SB A320-35-1057 original issue dated 15 June 2011. Airbus SB A320-35-1057 original issue dated 15 June 2011. Airbus SB A320-35-1058 original issue dated 15 June 2011.	
	B/E Aerospace SB 1XC22-0100-35-006 original issue dated 08 April 2011 or Revision 01 dated 15 December 2011.	
	The use of later approved revisions of these documents is acceptable for compliance with the requirements of this AD.
