<b>EASA</b>	<b>NOTIFICATION OF A PROPOSAL TO ISSUE AN AIRWORTHINESS DIRECTIVE</b>

<p><b>PAD No.: 13-168</b></p> <p><b>Date: 19 November 2013</b></p> <p>Note: This Proposed Airworthiness Directive (PAD) is issued by EASA, acting in accordance with Regulation (EC) No 216/2008 on behalf of the European Community, its Member States and of the European third countries that participate in the activities of EASA under Article 66 of that Regulation.</p>
<p>In accordance with the EASA Continuing Airworthiness Procedures, the Executive Director is proposing the issuance of an EASA Airworthiness Directive (AD), applicable to the aeronautical product(s) identified below. All interested persons may send their comments, referencing the PAD Number above, to the e-mail address specified in the 'Remarks' section, prior to the consultation closing date indicated.</p>	
<b>Design Approval Holder's Name:</b> VULCANAIR S.p.A.	<b>Type/Model designation(s):</b> P.68 aeroplanes

TCDS Number: EASA. A.385	
Foreign AD: Not applicable	
Supersedure: None	
<b>ATA 77</b>	<b>Engine Indicating System – Multifunction Engine Gauge – Inspection / Replacement</b>
Manufacturer(s):	Vulcanair S.p.A., formerly Partenavia

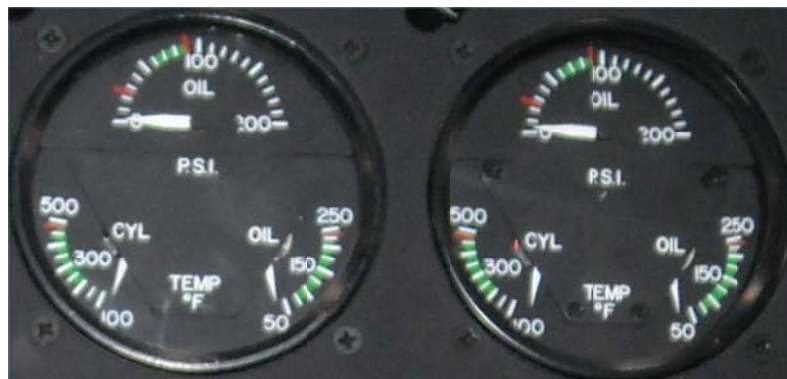
Figure 1. Correct configuration with Weston P/N 22-804-01-19A or A.I.D. P/N 18-1000-11

Red radial	Green arc	Red radial
Oil temperature		75 ÷ 245 °F	245 °F
Oil pressure	25 psi	60 ÷ 90 psi	90 psi
Cylinder Head Temperature (CHT)		200 ÷ 475 °F	475 °F

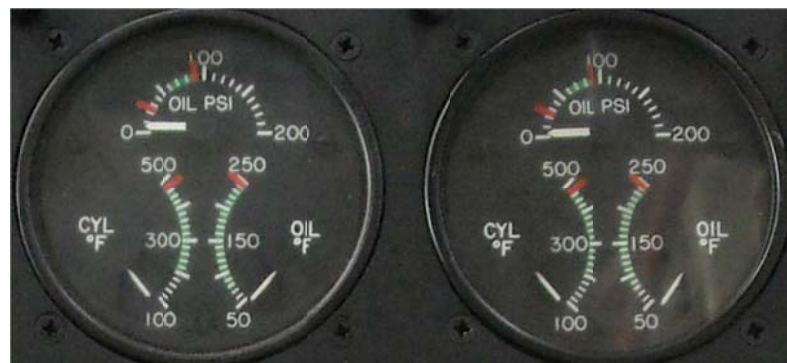
Figure 2. Correct configuration with Sigma Tek (Edo Aire) P/N 1U378-003-20, or P/N 1U378-003-20A
