SAIB: NE-16-19

Date: July 22, 2016

SUBJ: Turbine Engine Compressor Section – Stator Nozzle Distress

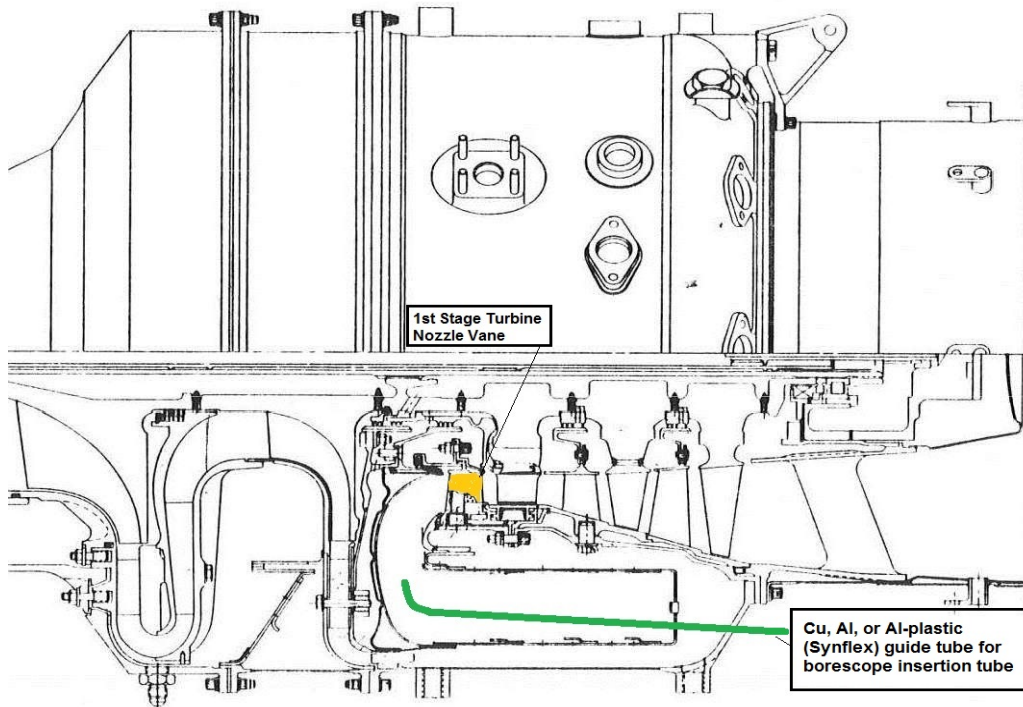
Figure 1. Cross-section of TPE331-11U Engine Power Section with Borescope Guide-Tube in Combustor

The flex insertion tube must be used with an appropriately sized guide tube as shown in Figure 1 below. When selecting a flex insertion tube, it is important to note that larger diameter tubes allow more light at the inspection site, but will have less flexibility. Synflex guide tubing provides the strength and flexibility of aluminum tubing and can be bent by hand. Some borescope suppliers may provide properly-sized Synflex tubing.

1. The FAA recommends a BSI at every fuel nozzle inspection interval when the fuel nozzle manifold is removed from the engine, not to exceed 450 hours since last inspection.
2. We also recommend BSI viewing through 4 fuel nozzle boss openings to obtain full inspection coverage of the 1st stage nozzle.
3. We also recommend using an RF Systems videoscope with a 3.9 mm or 6.9 mm flex insertion tube or equivalent.
