**FAA  
Aviation Safety**

**SPECIAL AIRWORTHINESS  
INFORMATION BULLETIN**

**SUBJ:** Equipment / Furnishings - Restraint Systems

**SAIB:** 2026-10R1

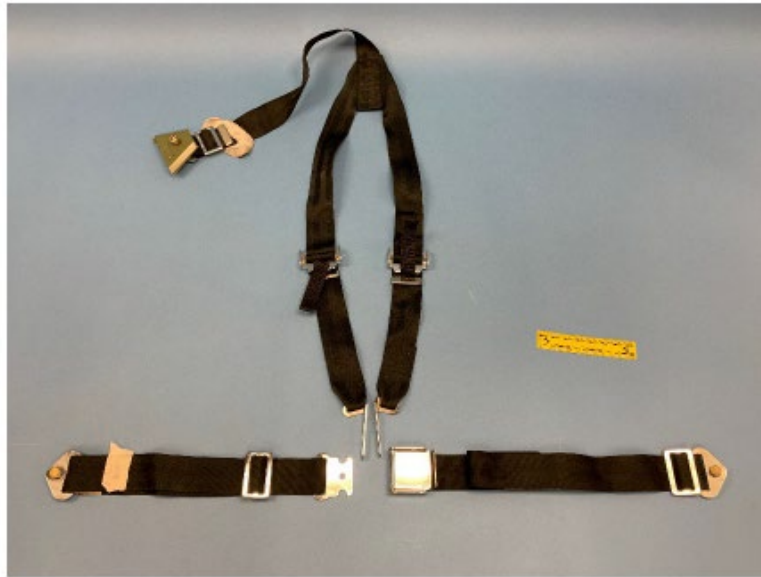
Figure 1  
Four-point restraint assembly

A search of NTSB public dockets identified at least fifteen other general aviation accidents resulting in full or partial failure of the occupants' restraint system. Many of these failures occurred at the Y-junction threading as shown in Figure 2. These accidents often involved serious or fatal injuries of the occupants. Further inspection of the accident findings revealed that these restraints are often designed to obsolete TSO requirements. Minimum torso restraint system performance requirements are currently prescribed in [TSO-C114](#) dated March 27, 1987. Minimum safety belt performance requirements are currently prescribed in [TSO-C22g](#) dated March 5, 1993. Both TSOs provide standards equivalent to SAE Aerospace Standard (AS) Document No. AS8043, "Torso

- Perform routine preflight and annual visual inspections of both the shoulder and pelvic restraints to check for signs of wear, deformation, discoloration, defects, or fraying. Special attention should be paid to the threading on the Y-junction that separates the two shoulder straps and connects to the fuselage attach strap behind the occupant’s head as well as the fastener hardware.
- Report findings of damage to the FAA point of contact. Please include the make, model, and serial number of the restraint and aircraft; a description of the damage; photographs; recommended inspection techniques to locate the damage; the damaged parts’ time in service; and any other information that may assist in our evaluation of this issue.
