| <b>Apex Aircraft</b><br>Bureau de Navigabilité<br>1, route de Troyes<br>21121 DAROIS - France<br>Tél +33 380 35 65 10<br>Fax +33 380 35 65 15<br>www.apex-aircraft.com | <b>S E R V I C E   B U L L E T I N</b><br><br>No. <b>030906</b> |
| <b>CAP10B - Wings - Inspection and service life</b> | <b>ATA : 050</b> |
| Supersedes : SB 16 all revs | |

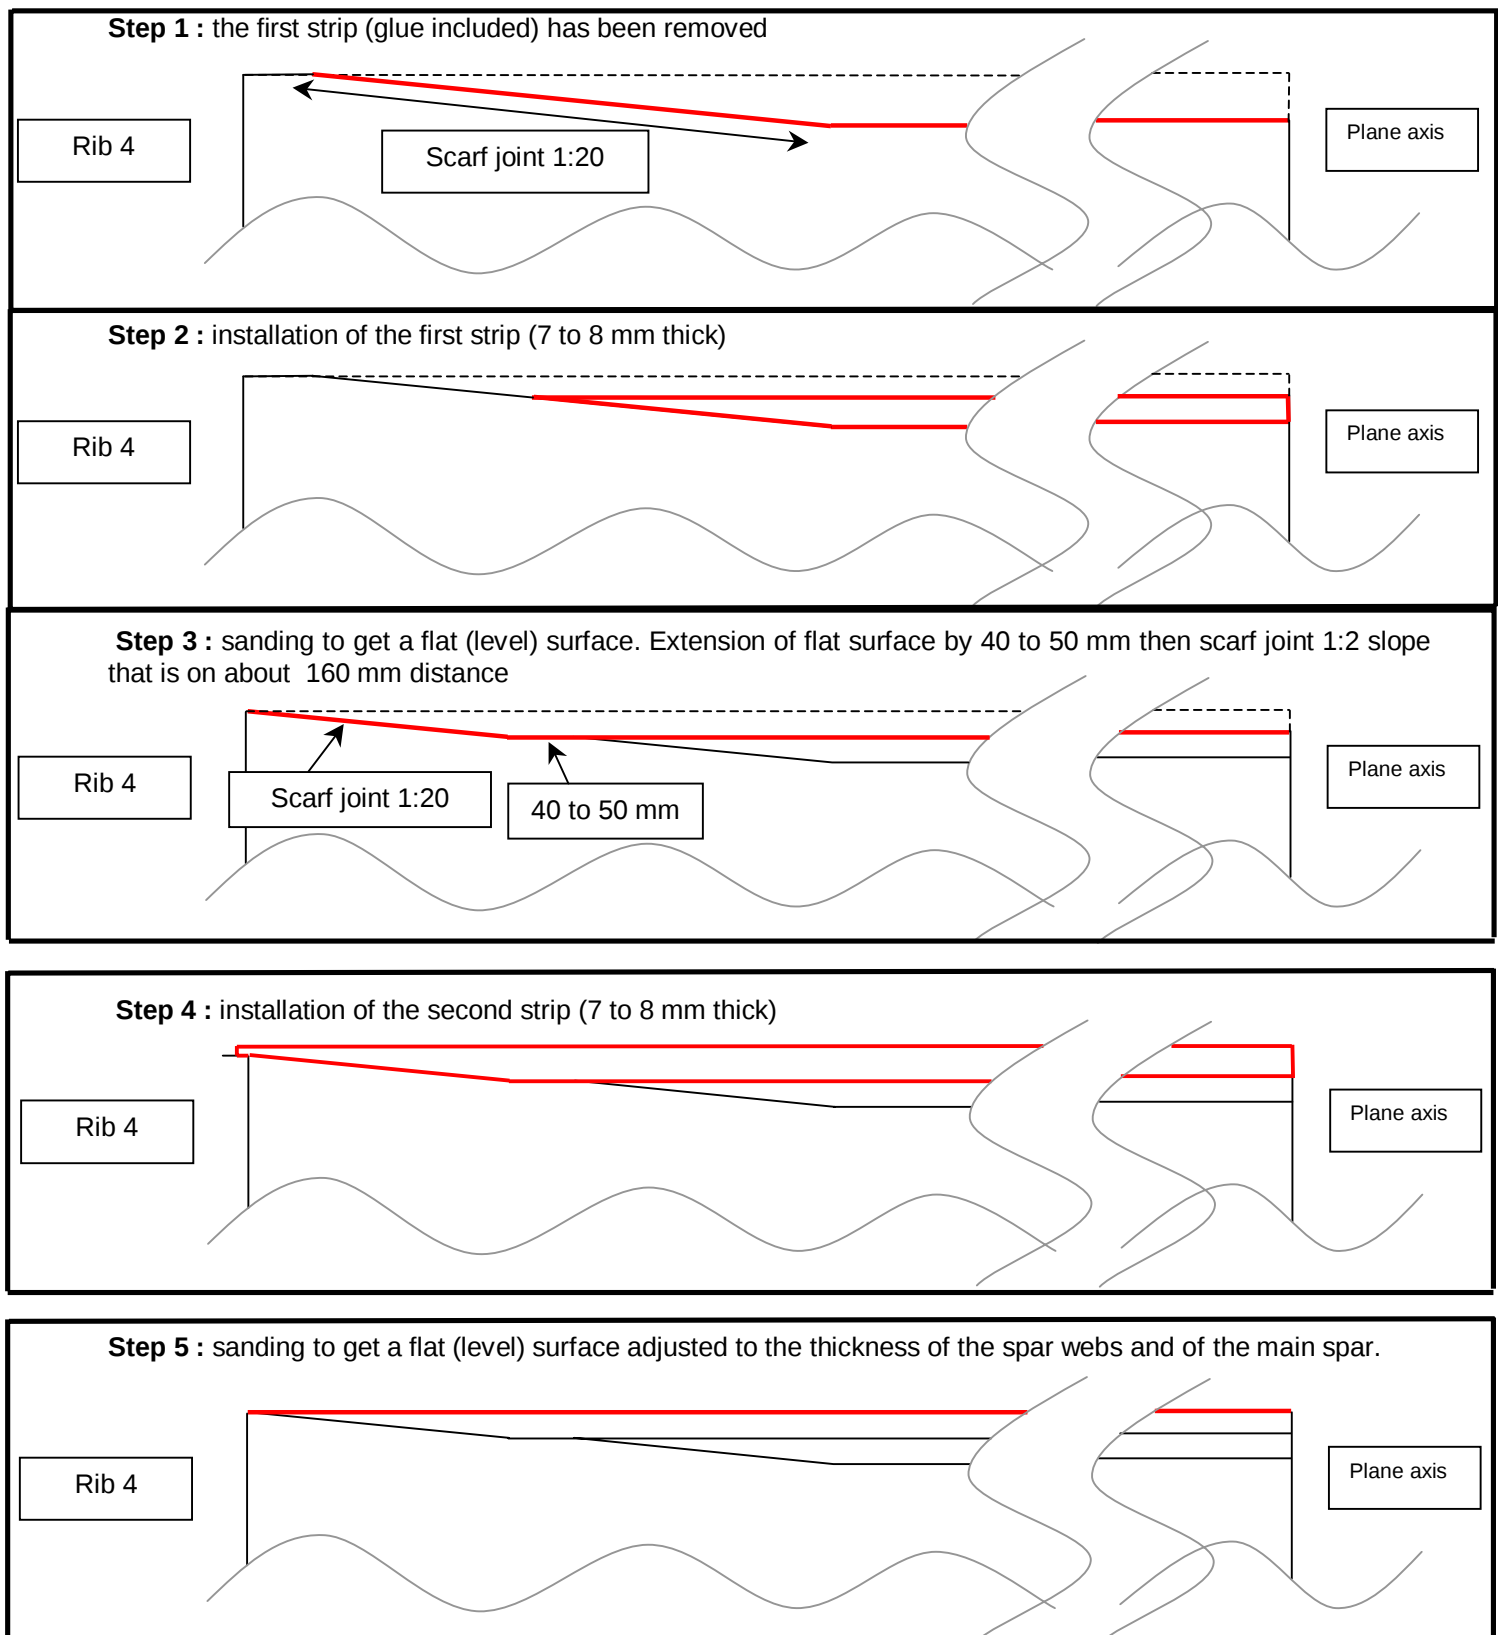
The symetrical repair concerns the LH rib nr4 till RH rib nr4 area, with strips in one piece if possible. If not, scarf joints are allowed only between the wings-to-fuselage attachment fittings (\*). The scarf joints must be distant by at least 3 times the length of the longer scarf joint, even for 2 scarf joints located on 2 neighboring strips.

- Provide for 2 or 3 spruce strips, top quality 1 (mini 3,91kg/mm<sup>2</sup> i.e. 383 daN/cm<sup>2</sup>, 7 to 8 mm thick) depending on the thickness of the removed part of spar cap.
- Carefully position and adjust each strip, making one or more marks to avoid any moving during gluing.
- During gluing, make sure glue is overflowing all along the periphery and particularly that it flows into the joints "spar caps/spar webs" while applying pressure.
- The scarf joints of each repair strip are staggered, leaving a 40 to 50 mm flat area.
- Refer to following step schematics.
- Do not reinstall the wing upper surface skin plywood yet.***

The different steps are the following (only the oval area is shown below) :

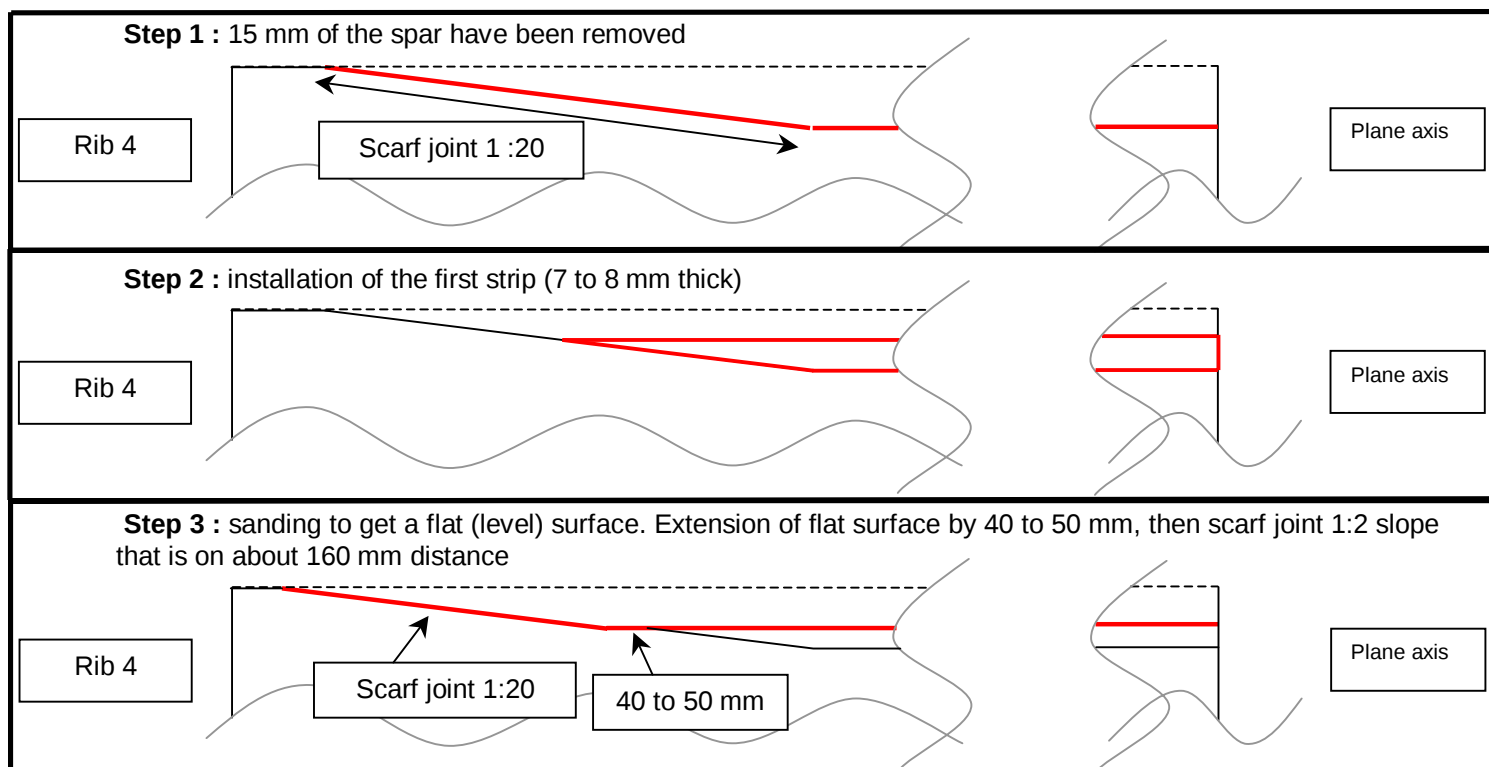
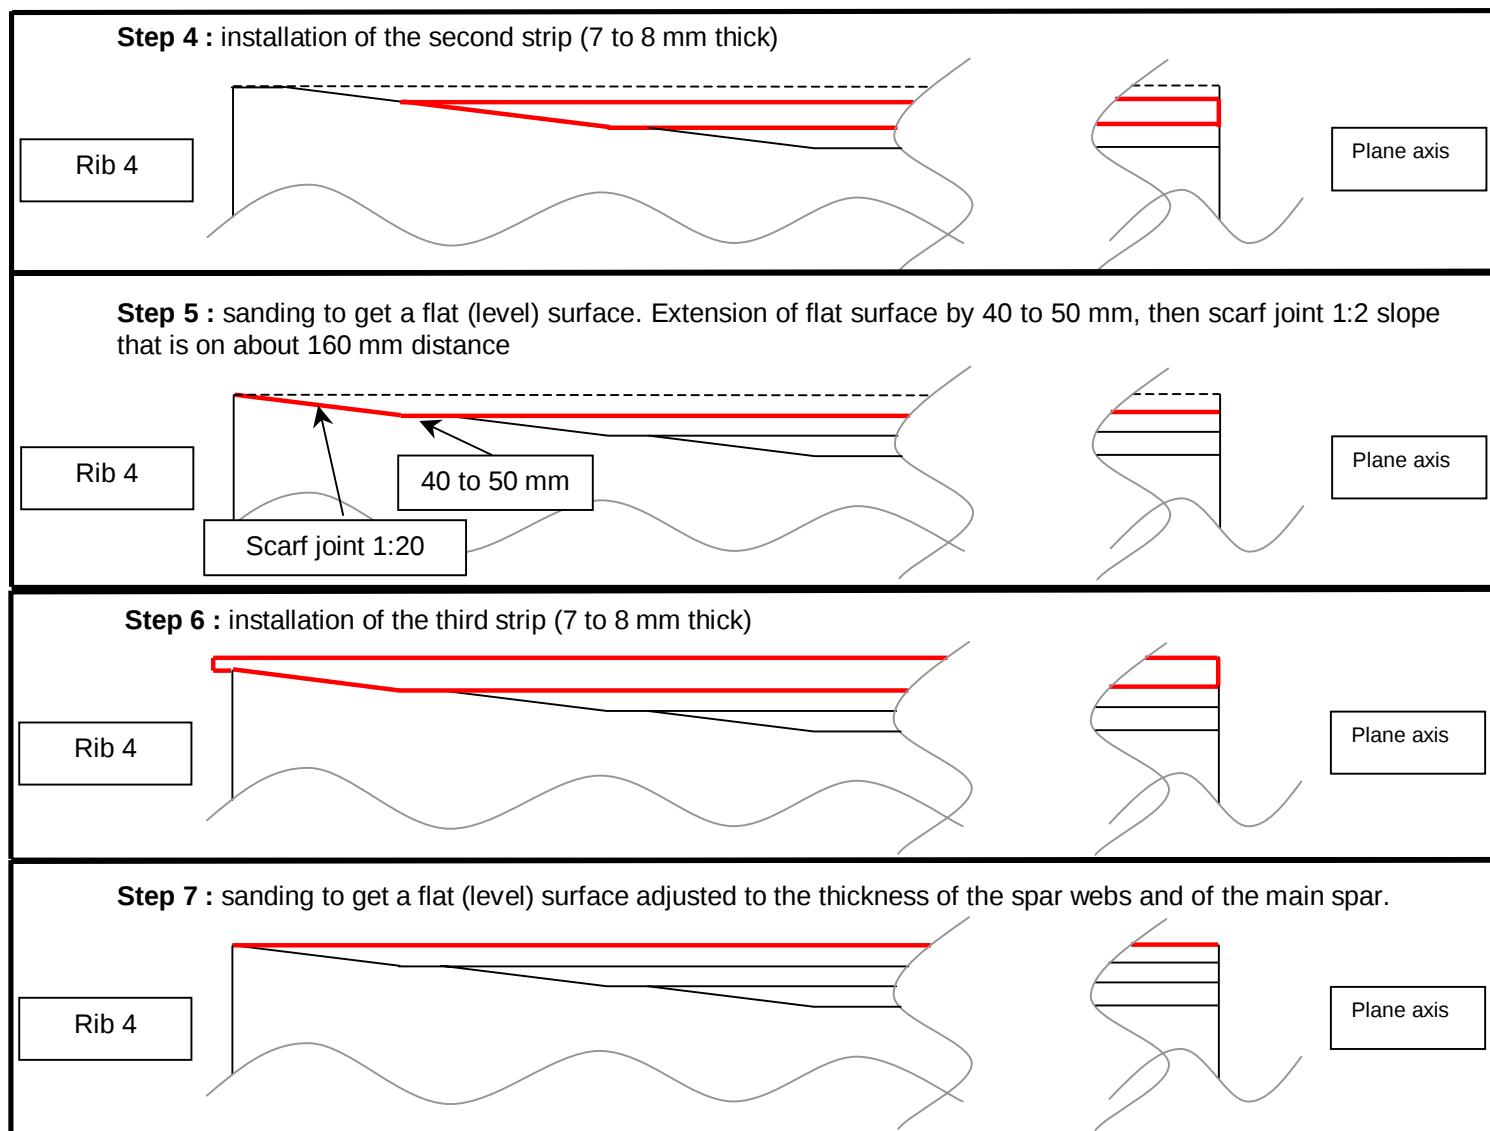
### CASE WITH THREE SPRUCE STRIPS

The symmetrical repair concerns the LH rib nr4 till RH rib nr4 area, with strips in one piece if possible. If not, scarf joints are allowed only between the wings-to-fuselage attachment fittings (\*). The scarf joints must be distant by at least 3 times the length of the longer scarf joint, even for 2 scarf joints located on 2 neighboring strips.

The different steps are the following (only the oval area is shown below) :

***Do not reinstall the wing upper surface skin plywood yet.***
