Apex Aircraft Bureau de Navigabilité 1, route de Troyes 21121 DAROIS - France Tél +33 380 35 65 10 Fax +33 380 35 65 15 www.apex-aircraft.com	S E R V I C E B U L L E T I N No. 030906
CAP10B - Wings - Inspection and service life	ATA : 050
Supersedes : SB 16 all revs

Models	Serial numbers affected
CAP10B with wood-only wing spar.	01-04, 1 to 282 <u>except</u> with modification 000302 ("CAP10C" wing)

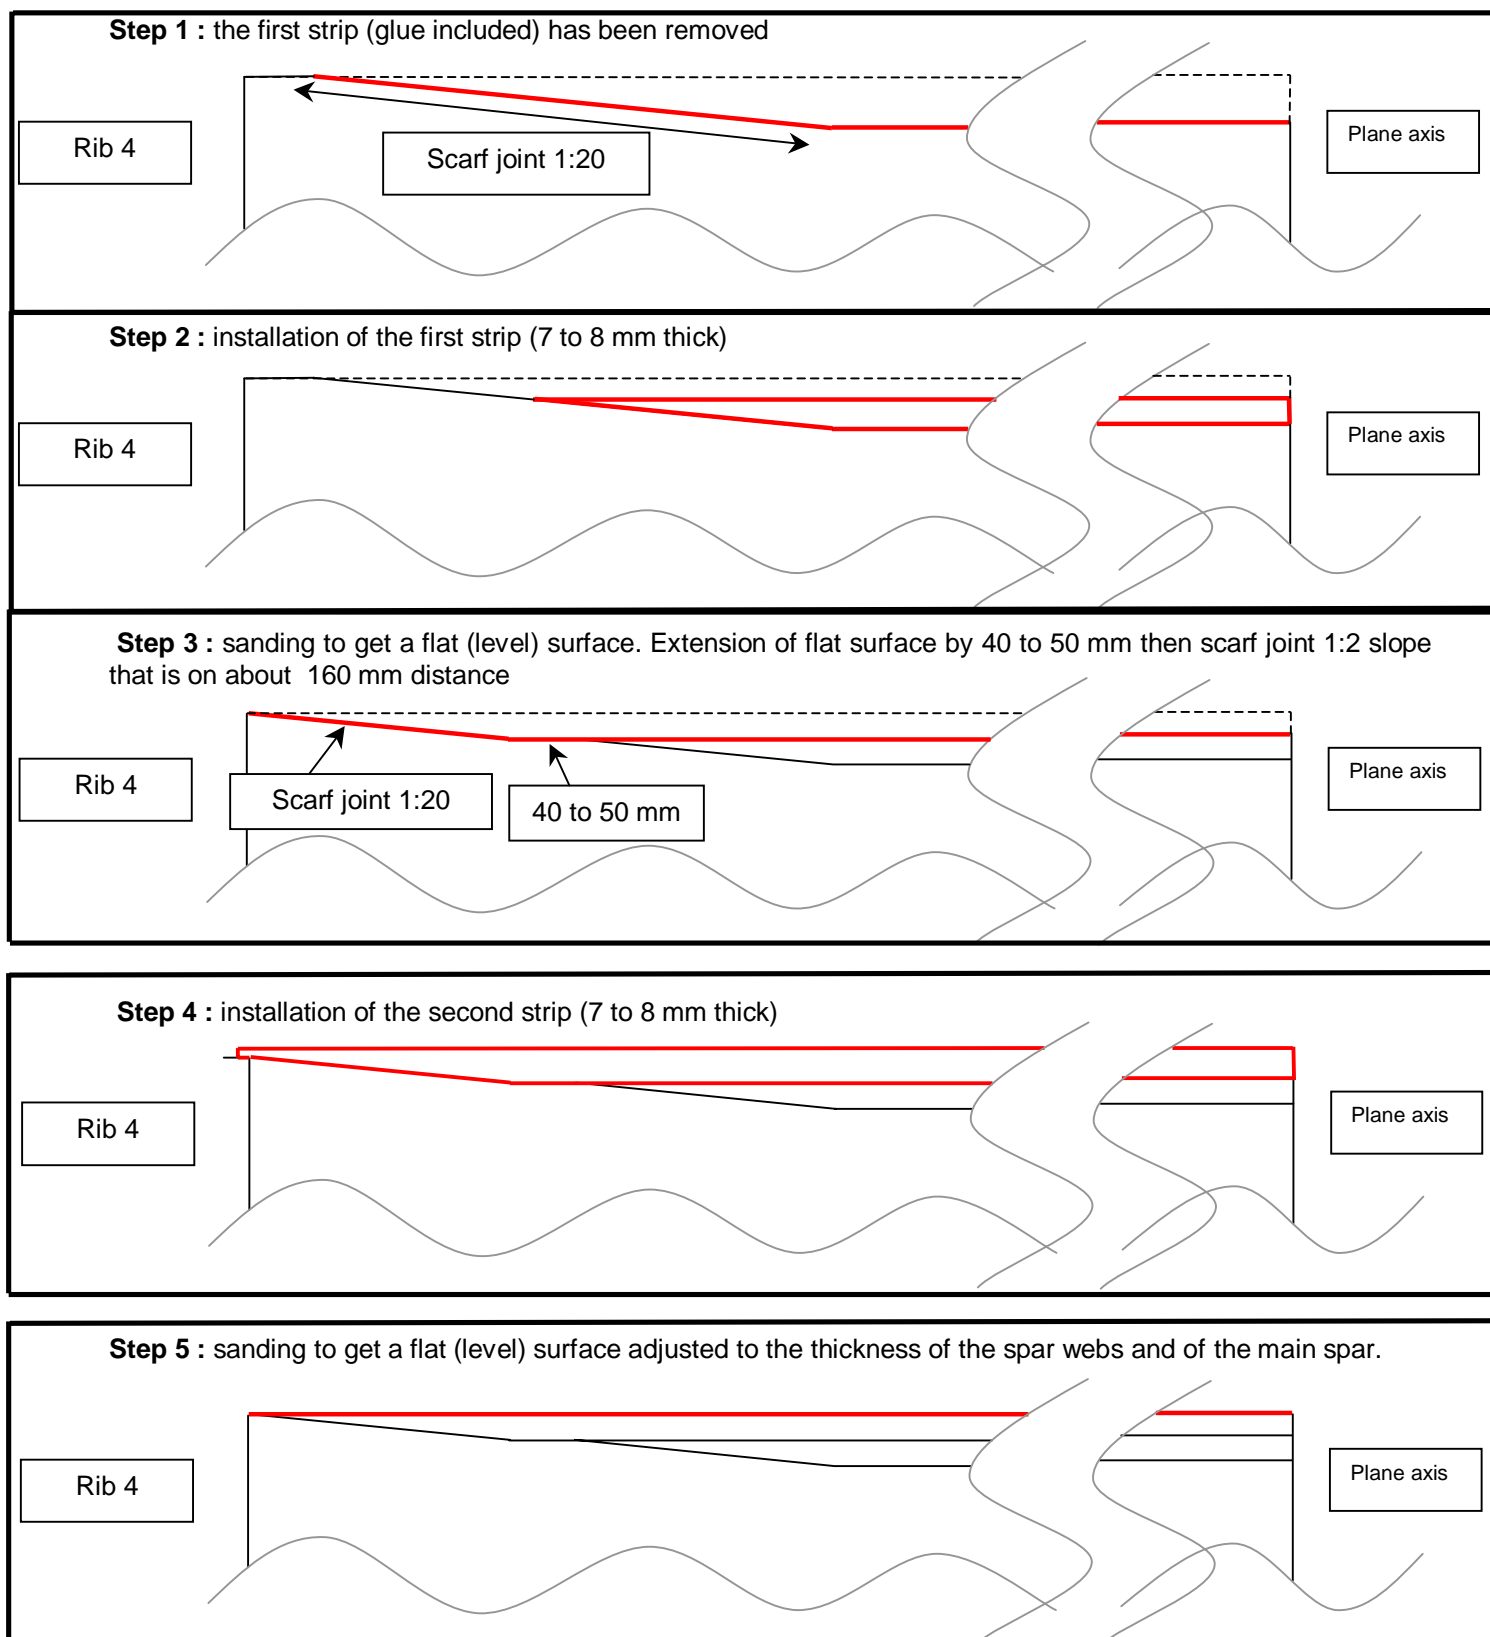
"After repair" overview schematic

The symmetrical repair concerns the LH rib nr4 till RH rib nr4 area, with strips in one piece if possible. If not, scarf joints are allowed only between the wings-to-fuselage attachment fittings (*). The scarf joints must be distant by at least 3 times the length of the longer scarf joint, even for 2 scarf joints located on 2 neighboring strips.

The different steps are the following (only the oval area is shown below) :
