## Airworthiness Directive

**AD No.:** 2022-0243

A330 and A340 aeroplanes

### ATA 36 – Pneumatic – Overheat Detection System Sensing Elements – Inspection

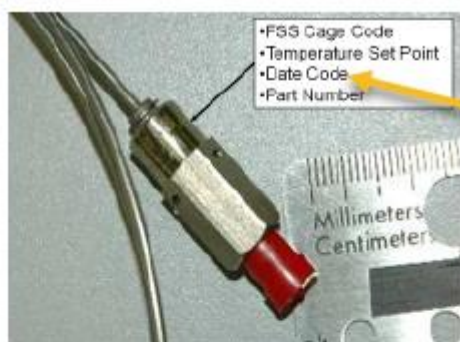
Figure 4-50. Identification Markings on Coaxial SE Male (Pin) Connector

## Appendix 1 – Affected Part – Locations of P/N and Date Code

**Affected part:** Overheat detection system (OHDS) sensing elements, also identified as 'Continuous Fire Detector', having a Part Number (P/N) and corresponding date code as listed in Section 1.A of the VSB, except those that passed an inspection (no discrepancies found; one face of the connector hex nut is marked) in accordance with the instructions of Section 3 of the VSB.
