COMMENT RESPONSE DOCUMENT

EASA PAD No. 19-117

[Published on 05 July 2019 and officially closed for comments on 02 August 2019]

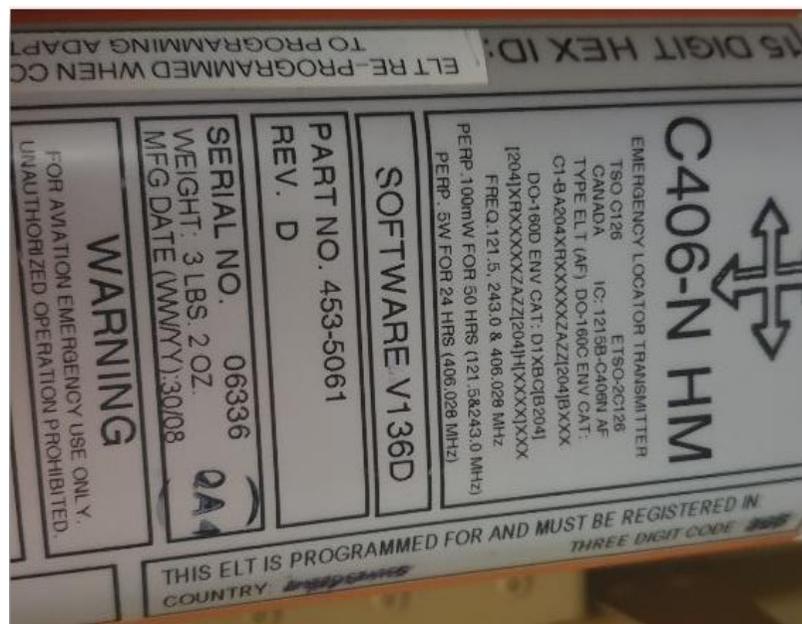
The following is a picture of the data plate on an ELT and as you can see the serial number is 06336, with a DOM of week 30 in 2008, this serial number is outside the serial number applicability of the PAD & SB.

This unit was entered into service on September 2009 and therefore my view is that it would need SB1000 carried out before September 2019, if I was to take the serial number listing in SB1000 and the PAD as the deciding factor we would mark these documents as N/A by serial number and do no inspections or modifications. Some guidance needs to be given on the 10 year requirements, also the turnaround time for compliance within the proposed 30 days will not be possible, I have spoken to a UK agent of ARC and they are stating a 6 to 8 week turn time.
