## COMMENT RESPONSE DOCUMENT

EASA PAD No. 20-184

[Published on 24 November 2020 and officially closed for comments on 22 December 2020]

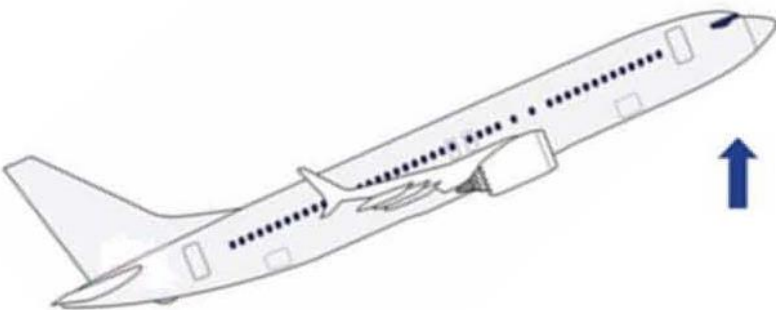
Important: Both Risk I and Risk II Must Be Read Simultaneously

Risk I (Physical Design): Predisposition to Upward Pitch*	Risk II: MCAS Requirement

A: Input from Single AOA Sensor
	1. False Positive Response
	Erroneously high AOA signal from single sensor <i>FACT: Lion Air Flight 610 and Ethiopian Airlines Flight 302</i>

2. False Negative Response
	<i>Could have been possible IF:</i> i. Normal AOA signal input sent to MCAS following damage to both sensors; no MCAS activation under truly high AOA: Stall Risk

1. False Positive Response: Activation of MCAS from erroneously high AOA signal input, resulting in uncommanded nose-down response.
2. False negative response: Failure of MCAS to activate in the presence of truly high AOA, increasing risk of aerodynamic stall.
3. Threshold of agreement: Precision between AOA sensors required to activate MCAS in software revision.
4. Physical Design: Structural layout and assembly of the aircraft (excluding MCAS software component).

1. False Positive Response
	Erroneously high AOA signal from two sensors, within threshold of agreement (e.g., loss of or damage to both sensors after takeoff with bird strike, IF an erroneously high signal is sent to MCAS)

2. False Negative Response
	i. Loss of AOA sensor agreement (e.g., damage to one AOA sensor); no MCAS activation under truly high AOA: Stall Risk

1. False Positive Response: Activation of MCAS from erroneously high AOA signal input resulting in nose down response	
2. False Negative Response: Failure of MCAS to activate in the presence of a truly high AOA, increasing risk of aerodynamic stall
