## COMMENT RESPONSE DOCUMENT

EASA PAD No. 24-079

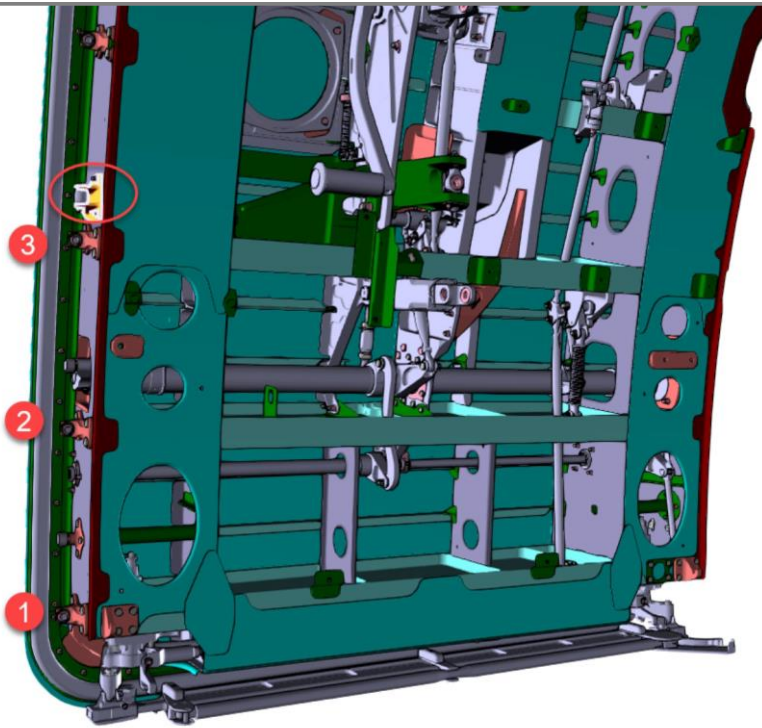
Modify Ref (A), to add correction statement approving use of the figure below (from Airbus) in lieu of Ref (B) Figure ICN-A330-A-52XX3150-A-FAPE3-01HWN-A-002-01 Fig.BB Sol.AA SHEET 1/2:

During review of Ref (B), it was observed that Figure ICN-A330-A-52XX3150-A-FAPE3-01HWL-A-001-01 Fig.BA Sol.AA SHEET 1 of 2 identifies the Inspection of the Peripheral Clearance between the FWD PAX/Crew Door and the Door Frame showing View A-A for FR16A and FR14.

However, while reviewing Figure ICN-A330-A-52XX3150-AFAPE3-01HWM-A-002-01 Fig.BA Sol.AA SHEET 2 of 2, it was observed that it shows a close up of View A-A on FR16A, while on FR14 refers to View B-B.
