COMMENT RESPONSE DOCUMENT

EASA PAD No. 25-086

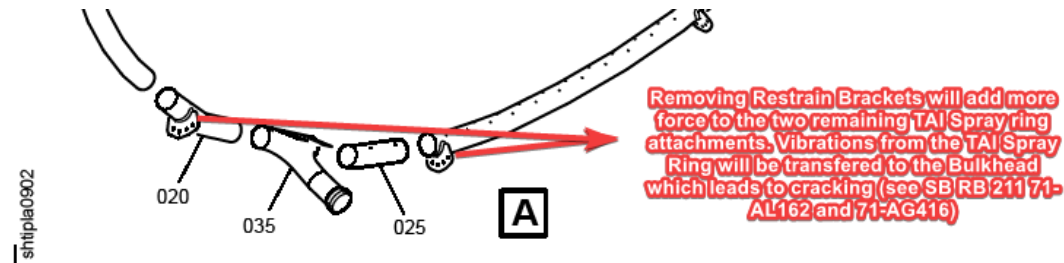
71-60-00

SPRAY RING, T.A.I. SYSTEM
(Sheet 2 of 3)
Figure 9A/GRAPHIC 71-60-00-99B-097-A01

LHT Engineering doubts that the installation of a longer feedpipe will eliminate the cracking of parts as the feedpipe adds additional weight and force to the spray ring and its attachments which are no longer supported by the restraint brackets.

LHT Engineering awaits more cracking of further parts such as bulkhead and TAI spray ring and its attaching brackets in worst case scenario led to a disengagement of the longer feed pipe.
