COMMENT RESPONSE DOCUMENT

EASA PAD No.: 26-009

Published on 22 January 2026 and officially closed for comments on 19 February 2026

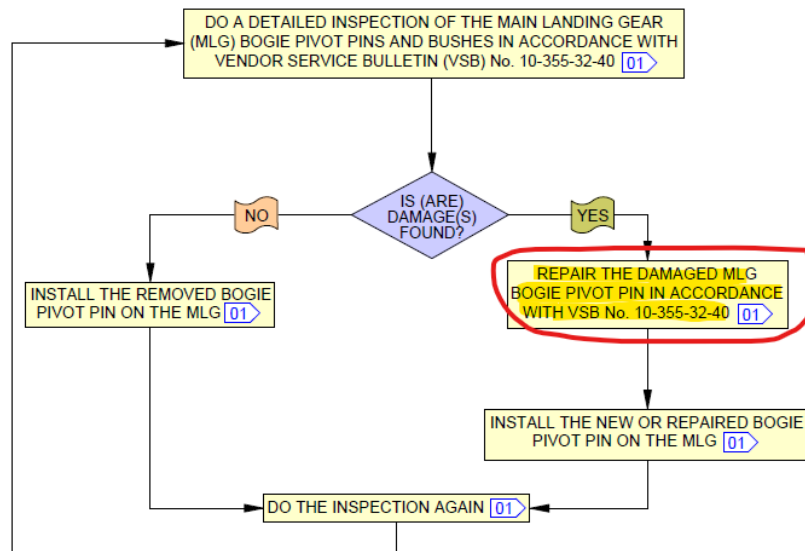
- (a) Do a detailed inspection of the LH MLG bogie pivot pin, MLG bogie/slider bushings and MLG bogie/slider lug bores in accordance with Ref. SAFRAN LANDING SYSTEMS (K0654) VSB 10-355-32-40 within the threshold given in PLANNING INFORMATION paragraph 1.E.(2).
- 1 If damage(s) is(are) found:
- Repair the damaged LH MLG bogie pivot pin in accordance with Ref. SAFRAN LANDING SYSTEMS (K0654) VSB 10-355-32-40.
 - Install the new or repaired LH MLG bogie pivot pin in accordance with Ref. Task A350-A-32-XX-P059-03ZZZ-720Z-A.
 - Do the inspection again in accordance with Ref. Task set A350-A-32-XX-P059-01ZZZ-93BZ-A at the interval given in the PLANNING INFORMATION paragraph 1.E.(2).

CONF ALL

- a. The accomplishment instructions in Ref.3 mentions to repair the BPP in accordance with Ref.2 in case of findings. QTR note that no repair is available in Ref.2 for the BPP, Bogie Beam and slider bushes that are inspected as per Ref.2
