EASA	AIRWORTHINESS DIRECTIVE

<p>AD No.: 2013-0267</p> <p>Date: 06 November 2013</p> <p>Note: This Airworthiness Directive (AD) is issued by EASA, acting in accordance with Regulation (EC) No 216/2008 on behalf of the European Community, its Member States and of the European third countries that participate in the activities of EASA under Article 66 of that Regulation.</p>
This AD is issued in accordance with EU 748/2012, Part 21.A.3B. In accordance with EC 2042/2003 Annex I, Part M.A.301, the continuing airworthiness of an aircraft shall be ensured by accomplishing any applicable ADs. Consequently, no person may operate an aircraft to which an AD applies, except in accordance with the requirements of that AD, unless otherwise specified by the Agency [EC 2042/2003 Annex I, Part M.A.303] or agreed with the Authority of the State of Registry [EC 216/2008, Article 14(4) exemption].	
Type Approval Holder's Name : AIRBUS	Type/Model designation(s) : A330 and A340-200/-300 aeroplanes

TCDS Numbers:	EASA.A.004, EASA.A.015
Foreign AD:	Not applicable
Supersedure:	This AD supersedes EASA AD 2012-0015 dated 23 January 2012.
ATA 32	Landing Gear – Main Landing Gear Bogie Beam – Inspection / Repa

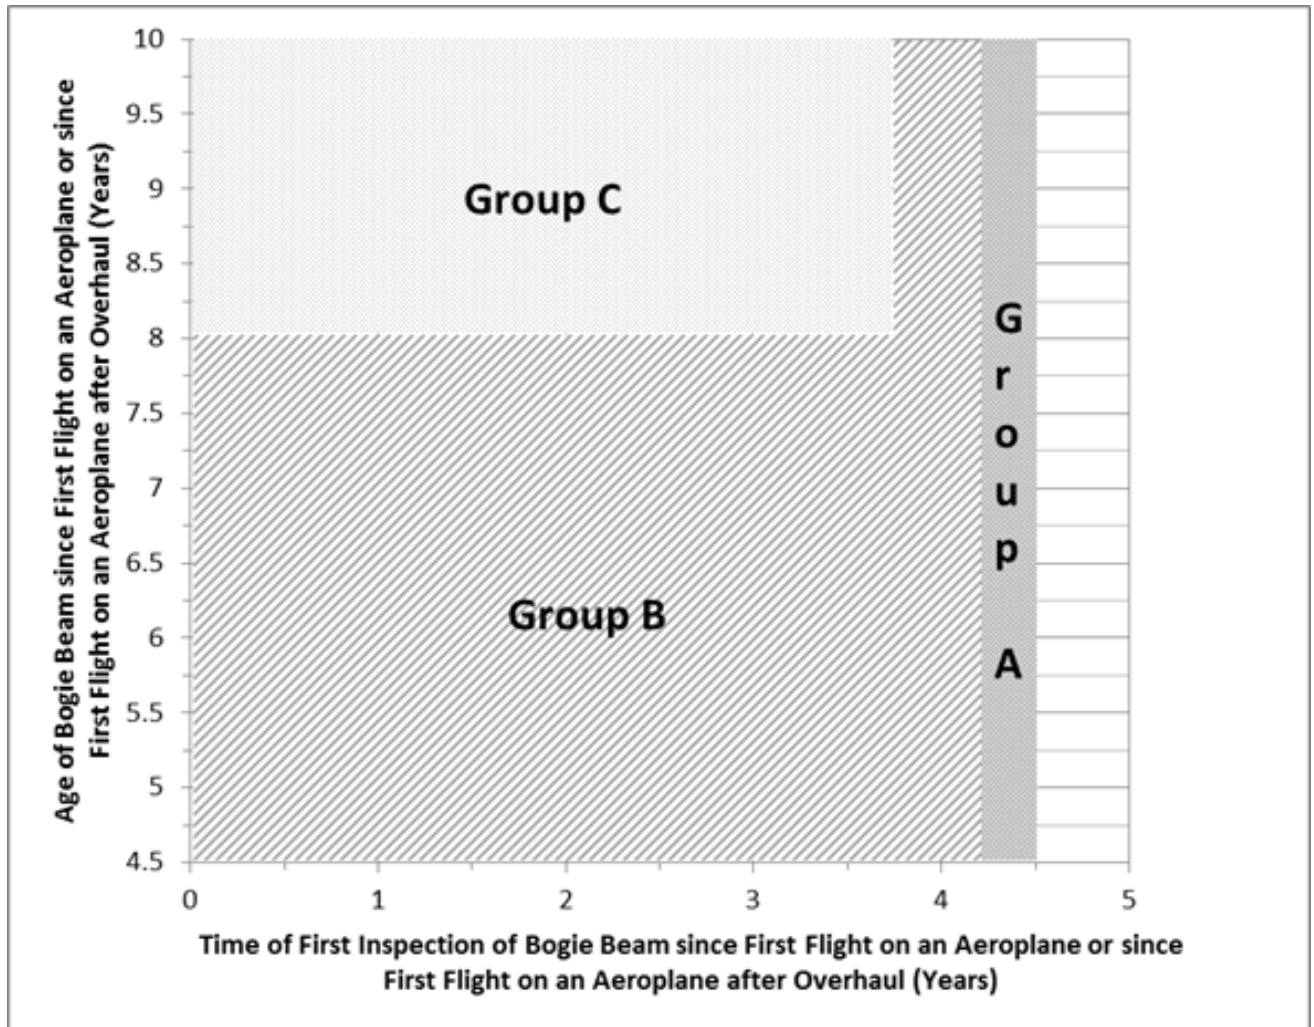
Appendix 1

Aeroplane Group determination chart for the specific one-time inspection
as required by paragraph (4.1) of this AD

- (4.1) Within the compliance time indicated in Table 1 of this AD, depending on the MLG bogie beam age and the date of the first inspection (see groups of aeroplanes in the chart in Appendix 1), clean the internal bore and accomplish a detailed inspection of internal surfaces of the LH and RH MLG bogie beams to detect any damage to the protective treatments and/or any corrosion and measure the paint thickness on the internal bore in accordance with the instructions of Airbus SB A330-32-3225 Revision 02 or SB A340-32-4268 Revision 03, as applicable to aeroplane type.
