<b>EASA</b>	<b>AIRWORTHINESS DIRECTIVE</b>

<p><b>AD No.: 2013-0267R1</b>  <b>[Correction: 08 May 2014]</b></p> <p><b>Date: 04 March 2014</b></p> <p>Note: This Airworthiness Directive (AD) is issued by EASA, acting in accordance with Regulation (EC) No 216/2008 on behalf of the European Community, its Member States and of the European third countries that participate in the activities of EASA under Article 66 of that Regulation.</p>	
<p>This AD is issued in accordance with EU 748/2012, Part 21.A.3B. In accordance with EC 2042/2003 Annex I, Part M.A.301, the continuing airworthiness of an aircraft shall be ensured by accomplishing any applicable ADs. Consequently, no person may operate an aircraft to which an AD applies, except in accordance with the requirements of that AD, unless otherwise specified by the Agency [EC 2042/2003 Annex I, Part M.A.303] or agreed with the Authority of the State of Registry [EC 216/2008, Article 14(4) exemption].</p>

<p><b>Type Approval Holder's Name :</b>  AIRBUS</p>	<p><b>Type/Model designation(s) :</b>  A330 and A340-200/-300 aeroplanes</p>	
<p>TCDS Numbers: EASA.A.004, EASA.A.015</p>		
<p>Foreign AD: Not applicable</p>		
<p>Revision: This AD revis

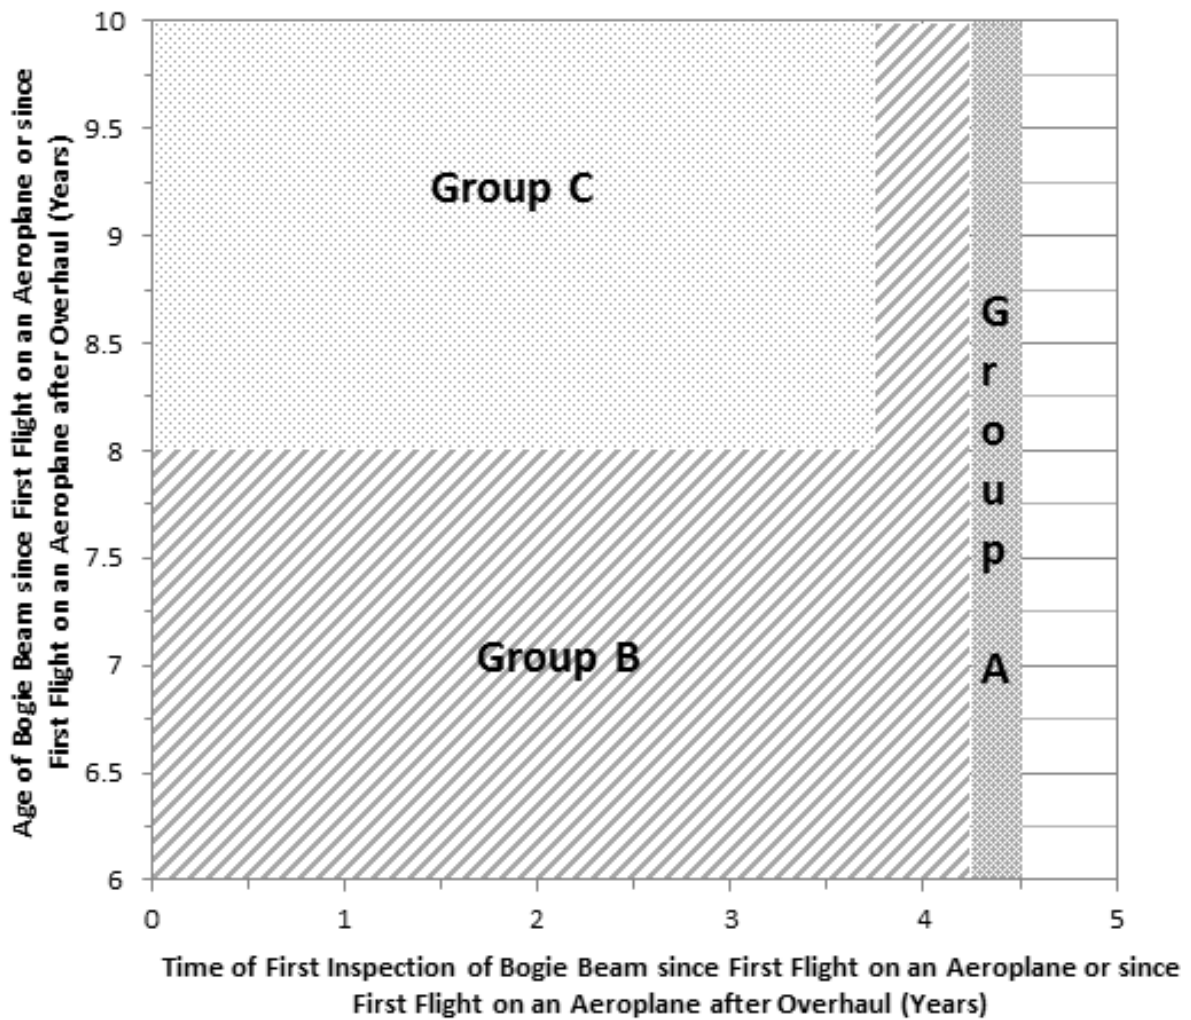
## Appendix 1

Aeroplane Group determination chart for the specific one-time inspection  
as required by paragraph (4.1) of this AD

- (4.1) Within the compliance time indicated in Table 1 of this AD, depending on the MLG bogie beam age and the date of the first inspection (see groups of aeroplanes in the chart in Appendix 1), clean the internal bore and accomplish a detailed inspection of internal surfaces of the LH and RH MLG bogie beams to detect any damage to the protective treatments and/or any corrosion and measure the paint thickness on the internal bore in accordance with
