<b>EASA</b>	<b>NOTIFICATION OF A PROPOSAL TO ISSUE AN AIRWORTHINESS DIRECTIVE</b>

<p><b>PAD No.: 10-100R1</b></p> <p><b>Date: 09 November 2010</b></p> <p>Note: This Proposed Airworthiness Directive (PAD) is issued by EASA, acting in accordance with Regulation (EC) No 216/2008 on behalf of the European Community, its Member States and of the European third countries that participate in the activities of EASA under Article 66 of that Regulation.</p>
<p>In accordance with the EASA Continuing Airworthiness Procedures, the Executive Director is proposing the issuance of an EASA Airworthiness Directive (AD), applicable to the aeronautical product(s) identified below. All interested persons may send their comments, referencing the PAD Number above, to the e-mail address specified in the 'Remarks' section, prior to the consultation closing date indicated.</p>	
<p><b>Type Approval Holder's Name :</b></p> <p>Eurocopter Deutschland GmbH</p>	<p><b>Type/Model designation(s) :</b></p> <p>MBB-BK 117 C-2 helicopters</p>

<p>TCDS Number : EASA.R.010</p>	
<p>Foreign AD : Not applicable</p>	
<p>Supersedure : None</p>	
<b>ATA 67</b>	<b>Rotor Flight Controls – Main Rotor Controls Power Boosted Section

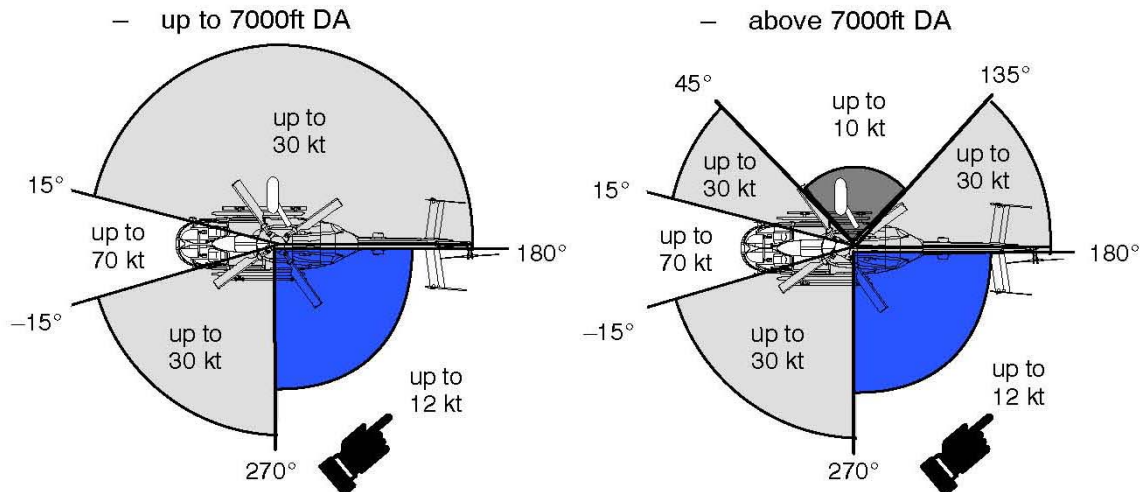
Hoist operations have been demonstrated under the following conditions:

**EFFECTIVITY** *External Hoist System (RH) installed.*

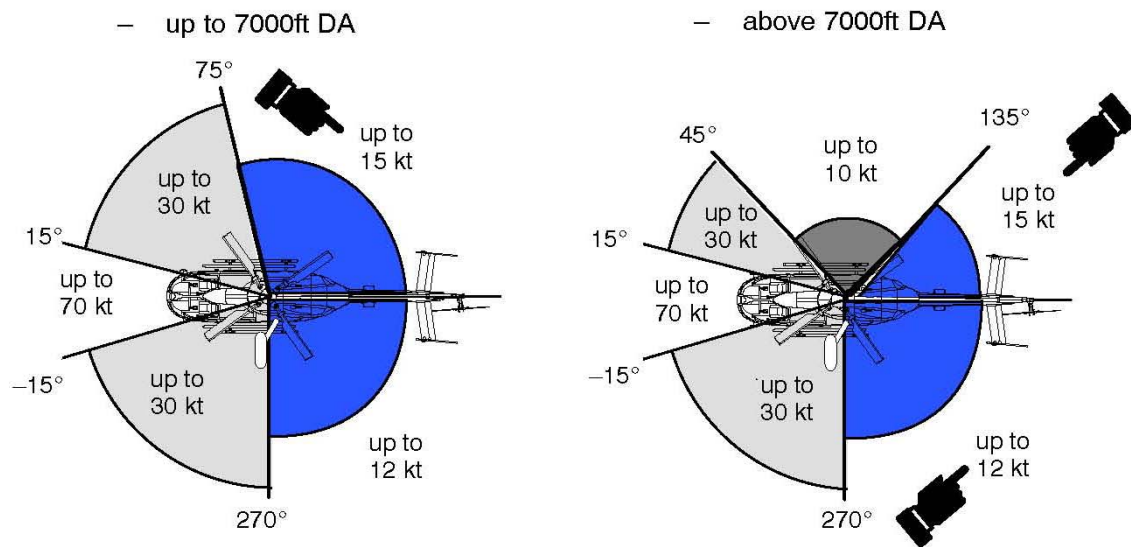
**EFFECTIVITY** *External Hoist System (LH) installed.*
