Safety Information Bulletin Airworthiness

SIB No.: 2017-09

Issued: 22 June 2017

# Subject: Lack of Monitoring of DU-875, DU-885 and DU-885AF Displays

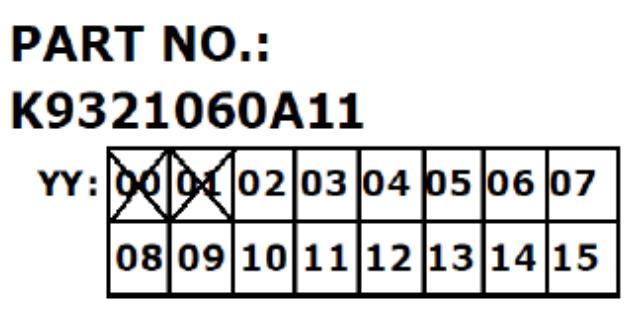
The display part number is composed of 11 alphanumerical characters plus 2 additional digits as striked out on the equipment plate. These two digits are referred to as the revision index in Appendix 1 of this SIB.

The example below shows the part number K9321060A11 with revision index 01:
