U.S. Department  
of Transportation  
**Federal Aviation  
Administration**

Subject: Alternative Method of Compliance (AMOC) to AD2008-15-06 paragraph (e)(3)

**SUBJECT:** Addition of access holes to facilitate inspection called out in **SEB 07-2**, Engine Mount Bracket Inspection

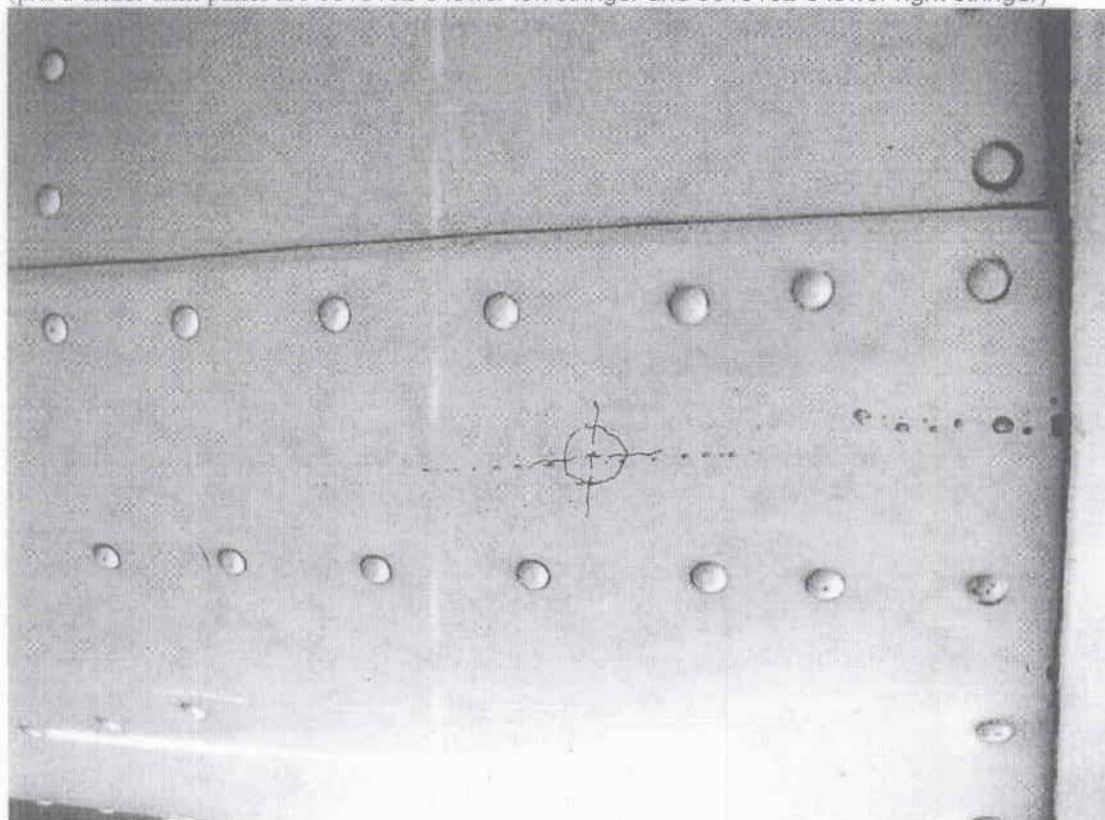
Photo 2: Lower left engine mount stringer

1. The added holes should be located midway between the two rivet lines that attach the longitudinal hat section stringer to the fuselage skin and between the 3rd and 4th rivet, in these rivet lines common to the skin lap, aft of the firewall. (see attached photos)

(p/n's under skin panel are 0513132-5 lower left stringer and 0513132-6 lower right stringer)

To facilitate these inspections, and at the option of the aircraft operator, one 0.5 inch diameter hole may be added on the fuselage skin aft of each of the 4 brackets that are to be inspected. These added holes would facilitate borescope inspection of the bracket and its engine mount attach hole for deformation and cracks and should be installed subject to the following:

2. Remove any burrs and break all sharp edges after holes are drilled using a fine crocus cloth or equivalent.
3. To preclude corrosion: Apply brush alodine or a suitable epoxy primer to the hole I.D.

4. After inspection is complete, seal the hole to preclude entry of water, air or Carbon monoxide. A suitable plug button can be used if sealed with RTV (or equivalent) to prevent leakage or loss due to vibration. A circular patch of aircraft fabric could also be cemented to the skin to cover the added hole and seal it from any leaks.
