CESSNA AIRCRAFT COMPANY  
**MODEL FR172 SERIES**  
SERVICE MANUAL

**SUPPLEMENTAL INSPECTION NUMBER: 55-10-01**

1. **TITLE:**  
Horizontal Stabilizer, Elevators and Attachments Inspection

2. **EFFECTIVITY**  
FR17200001 thru FR17200590

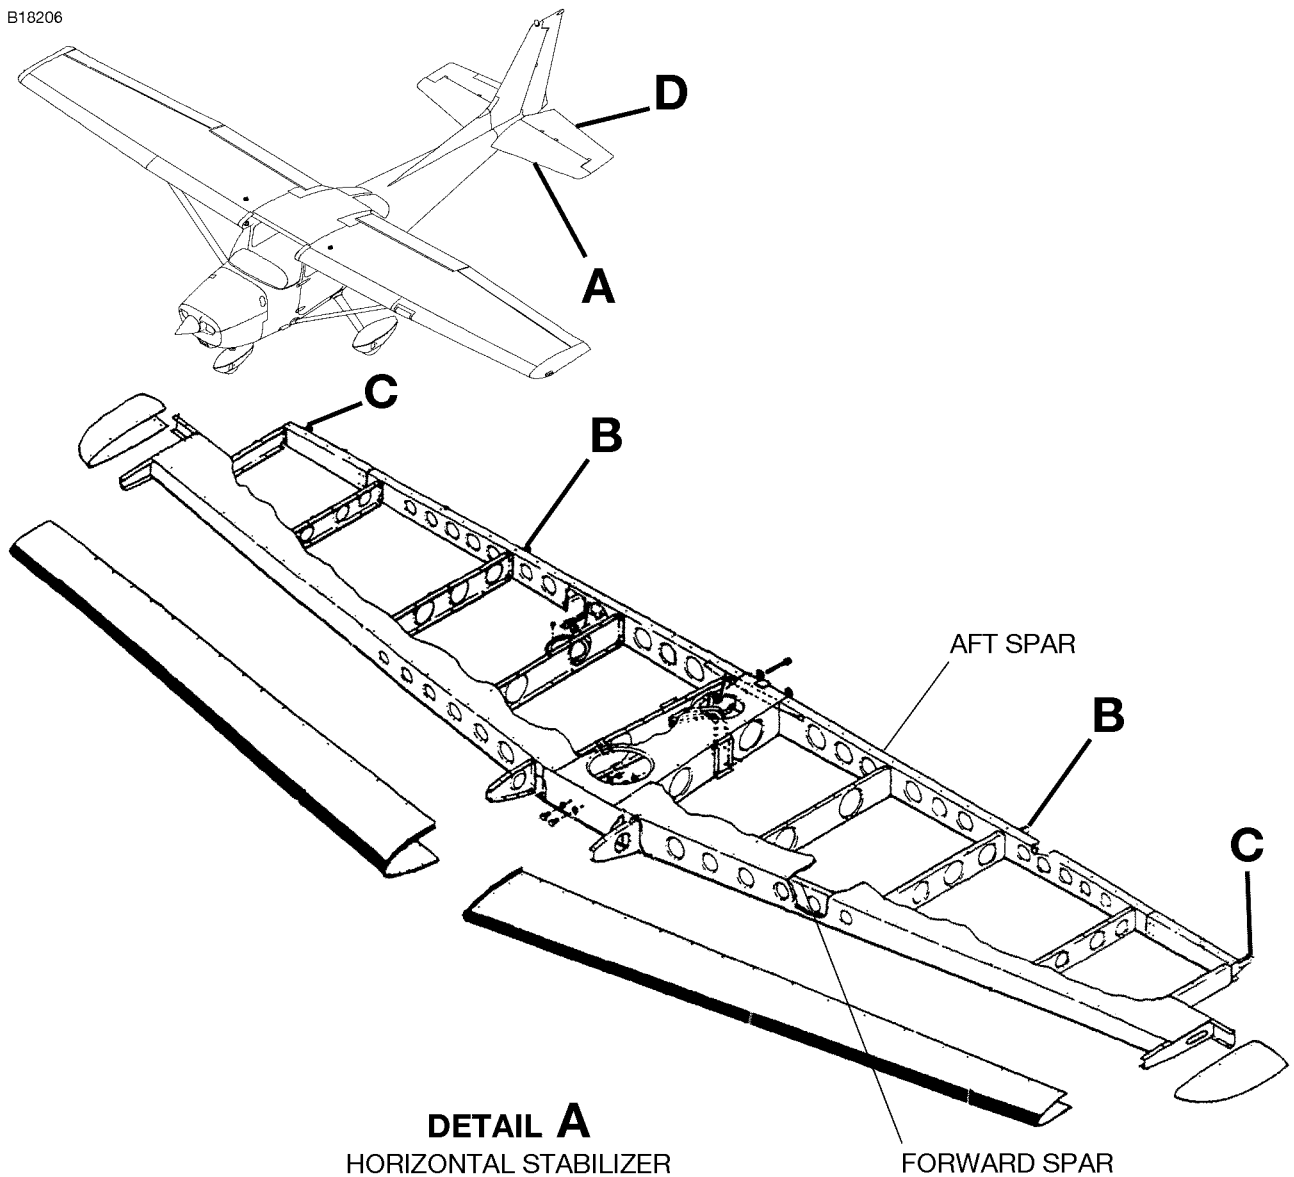
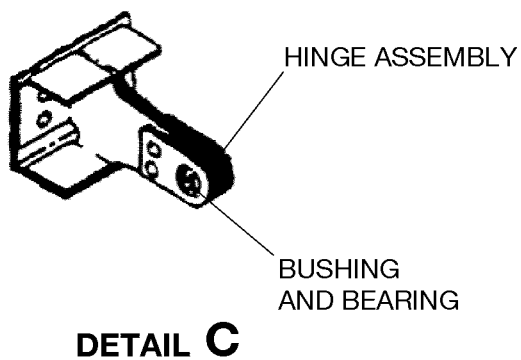
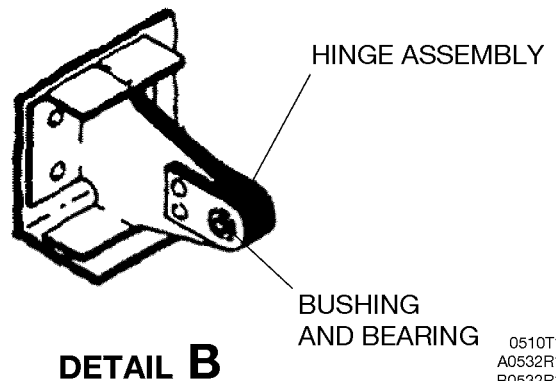
HORIZONTAL STABILIZER, ELEVATORS AND ATTACHMENTS INSPECTION  
 Figure 1 (Sheet 1)

- B. Visually inspect stabilizer and elevator for condition, cracks and security; hinge bolts, hinge bearings for condition and security; bearings for freedom of rotation; attach fittings for evidence of damage, wear, failed fasteners and security. Refer to Figure 1.

- (1) Clean area before inspecting if grime or debris is present.
- C. Visually inspect the torque tube for corrosion and rivet security. Pay particular attention to the flange riveted onto the torque tube near the airplane centerline for corrosion.

- (1) Clean area before inspecting if grime or debris is present.
- D. Visually inspect forward and aft stabilizer and elevator spars, ribs and attach fittings for cracks, corrosion, loose fasteners, elongated fastener attach holes and deterioration. Pay particular attention to the skins at the location where stringers pass through ribs and at the leading edge skin close to the fuselage. Apply finger pressure at the stringer intersection or the rib to spar juncture to check for free play indicating a broken rib. Visually inspect the forward stabilizer attachment bulkhead for cracks.

- (1) Clean area before inspecting if grime or debris is present.
- E. If corrosion or a frozen bearing is found, conduct a surface eddy current inspection for cracks of each elevator hinge attach fitting. Refer to Section 2A-13-01, Nondestructive Inspection Methods and Requirements, Eddy Current Inspection – Surface Inspection, for additional instructions. The inspection is for the aluminum structure outside of the bearing, so set the instrument for aluminum.

- F. Visually inspect the trailing edge portion of the elevator for indications of cracks, corrosion or deterioration. Visually inspect the attachment of the trim tab horn to the trim tab.

Replace damaged bolts and nuts. Replace damaged fittings and small parts. Replace damaged or loose rivets. Hinge bearings are pre-packed with grease, which will eventually oxidize and harden after years of service. Several applications of penetrating oil will help free up a stiff bearing. It is the owner's/operator's option to replace stiff bearings. Make repairs in accordance with Section 17 (Structural Repair) of the Model FR172 Service Manual. Coordinate any repair not included in Section 17 with Cessna Customer Service prior to beginning the repair.
